SALTERFORTH WAR MEMORIAL

MEMORIAL INSPECTION REPORT

Pendle Borough Council

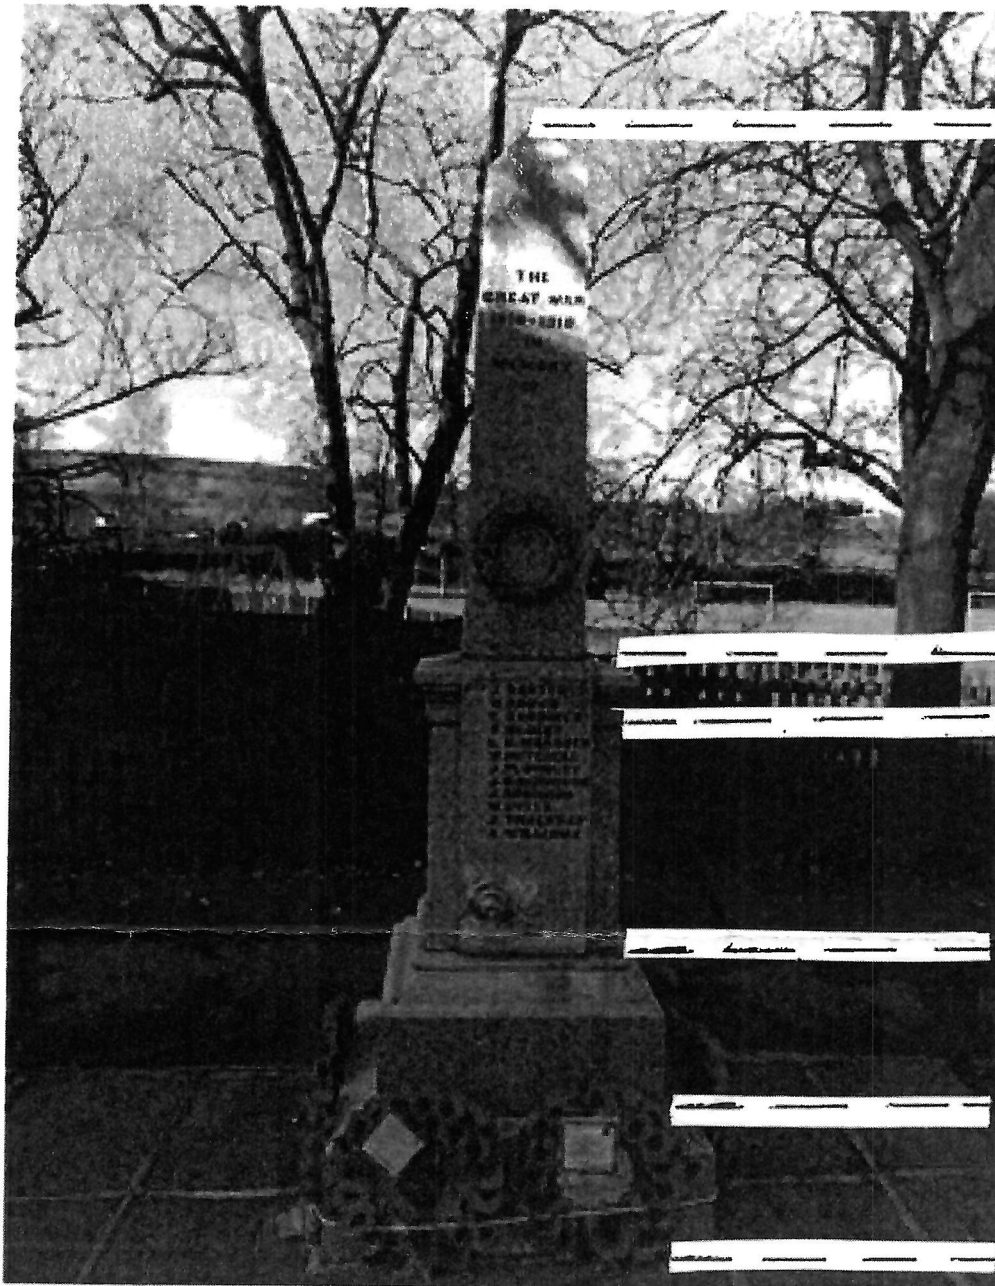
Section 1- Height 1372mm, Width 305mm

Section 2 - Height 203mm, Width 152mm

Section 3 – Height 559mm, Width 457mm

Section 4 – Height 355mm, Width 660mm

Section 5 – Height 254, Width 864mm

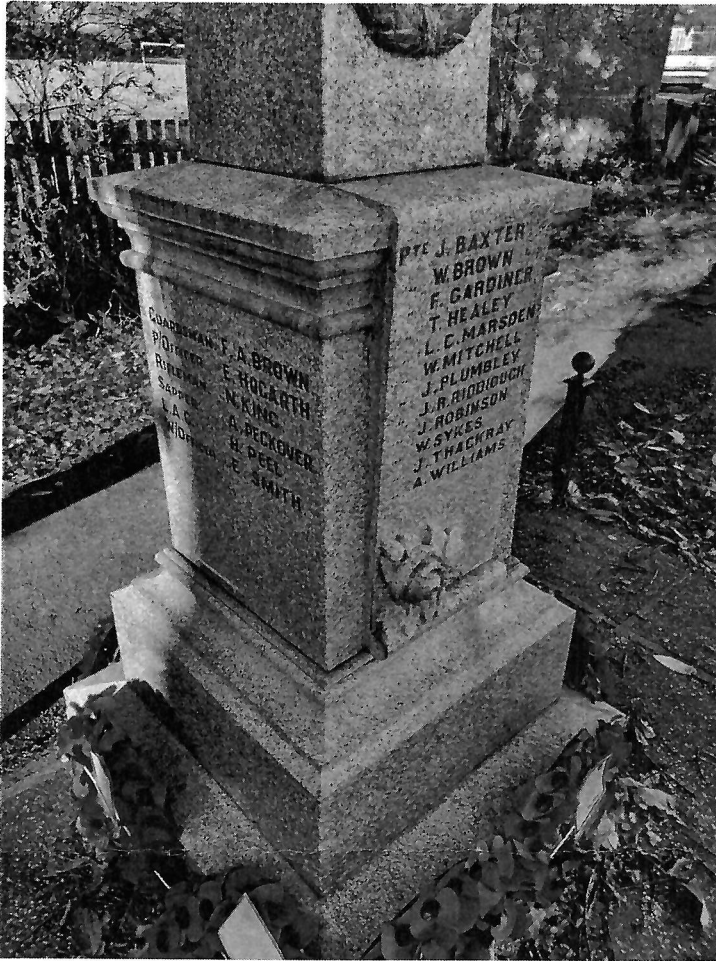
SALTERFORTH MEMORAIL INSPECTION

The memorial does not show signs of any stress fractures at any of the joints within the sections of the memorial. This may occur due to frost and snow freezing at these points.

The memorial has been hand tested to see if there is any movement at the highest possible reach point.

There are no noticeable movements of the memorial whatsoever.

An inclinometer was used to measure any leaning of the memorial which measures the lean, 100 being upright and the level recorded a lean of 11 with the reading showing 89/100.

Though the inclinometer does show signs of some movement factors to bear in mind are:

1. Close proximity to the main road B6383 volume of traffic.
2. The Flagged area having settled when the memorial was erected.
3. Significant rainfall over time soften of the ground under the flagged area.

The report has not highlighted any structural defects with the memorial though there does show a lean of slight 11 degrees from 100 (Inclinometer), This may be due to being situated near a busy road and vibration caused by heavy traffic.

Possibility that the flagged area has settled overtime and contributed to the slight lean.

Recommend future measurements with the Inclinometer to see what if any future movement is noted.

I would recommend that the lean is measured in 12 months' time and if there is no further movement of significance then further inspection every couple of years.

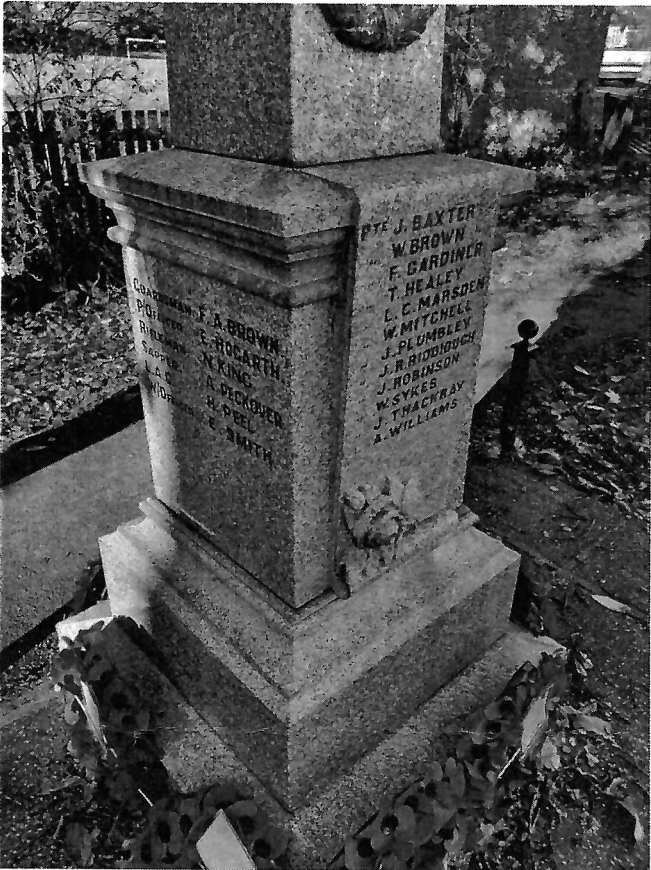
SALTERFORTH WAR MEMORIAL LETTERING/INSCRIPTIONS

Upon inspection of the lettering which is flush lead letters painted black, the letters are all intact and no discoloration of the paint.

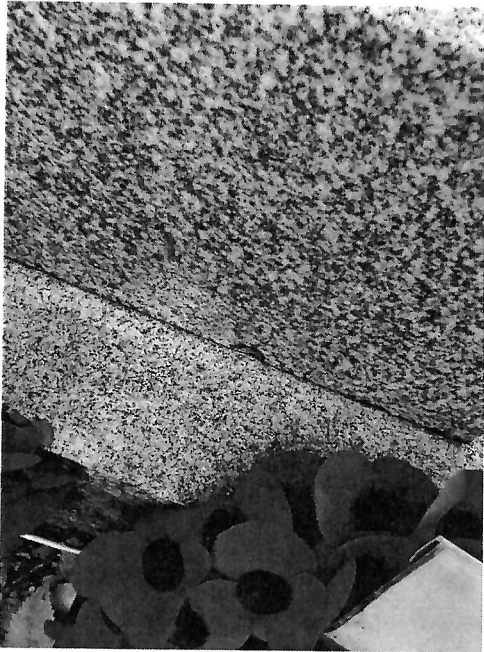
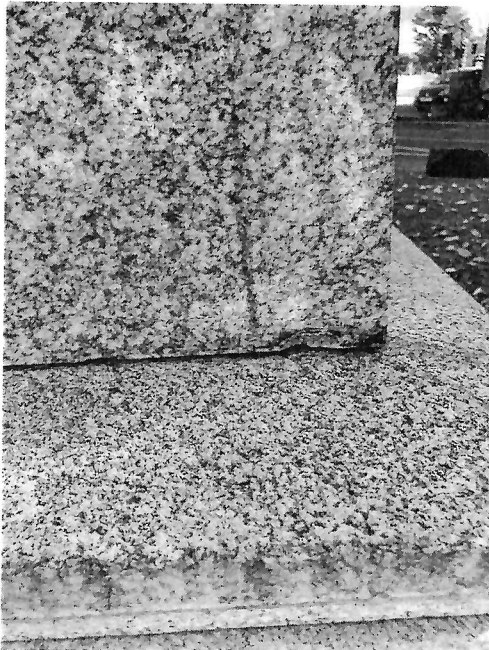
SALTERFORTH WAR MEMORAIL SLIGHT DAMAGED AREAS

These 2 photographs show areas where the memorial have a few small chips on some edges on the memorial. These chips do not affect the stability of the memorial as they are difficult to see and really are only cosmetic damage.

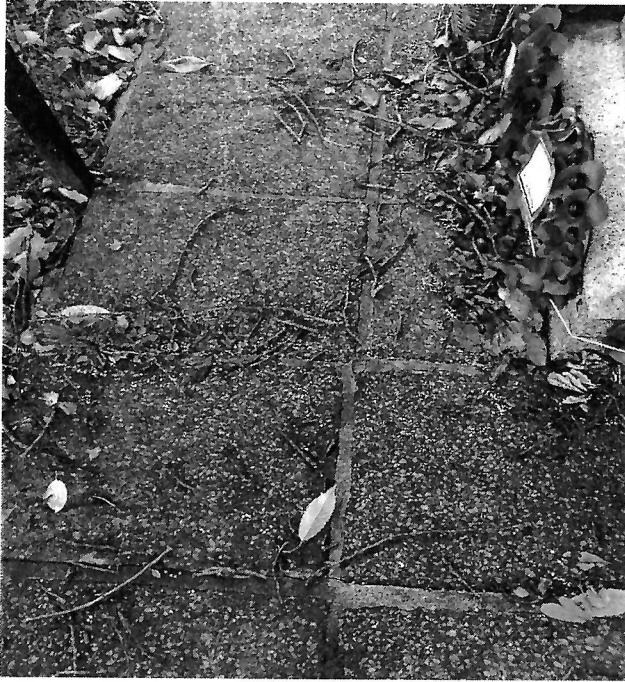
SALTERFORTH WAR MEMORIAL STANDING AREA

The area is flagged with pointing of the joints, there are no broken flags and the pointing is intact.

Though on closer inspection some joints have small hair line cracks the pointing is not breaking apart. There are no raised flags presenting a trip hazard

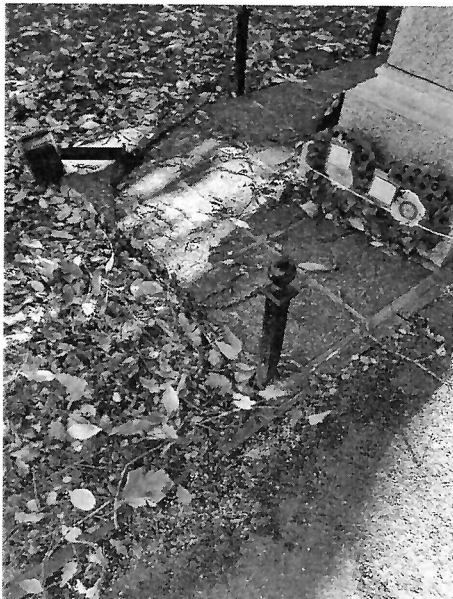
There are 5 metal posts situated around 3 sides of the flagged area. One of the posts has broken off from its setting thus creating a trip hazard via the post and the chain laying on the ground. The post could be reset or a new post installed. There is some wear and tear on the posts and chains but these are only cosmetic.

The posts that surround the 3 sides of the flagged area do need attention especially the 1 that is broken from its foundation, again the rest purely cosmetic.
