# the play inspection company

Annual Inspection

Pendle Borough Council

Salterforth

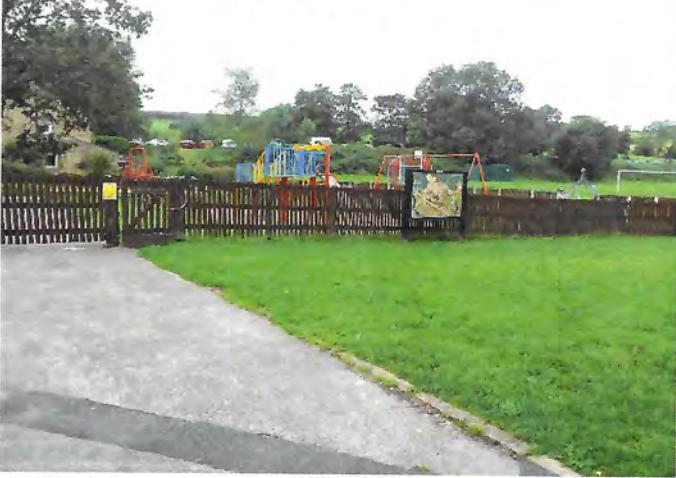
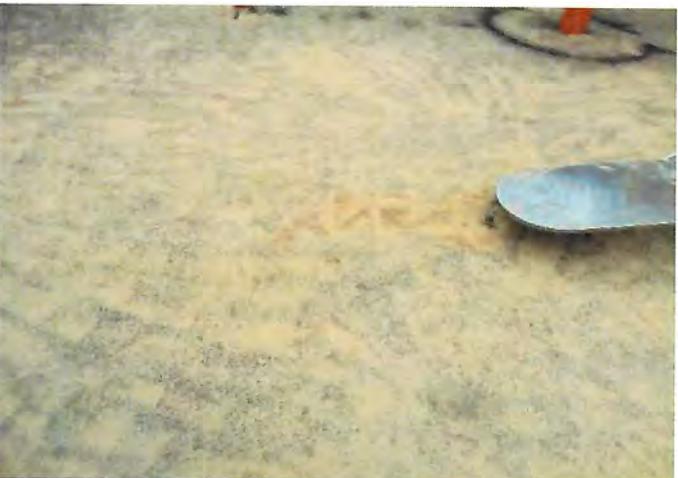
8 - Low Risk (Finding 1)	
<b>Item:</b> Ancillary Items - Site General	<b>Risk Level:</b> L - Low Risk
<b>Manufacturer:</b> Owner/Operator	<b>Surface:</b> N/A

<b>Finding:</b> Sand has migrated onto the impact attenuating surface	<b>Action:</b> Remove and maintain
8 - Low Risk (Finding 2)	
<b>Item:</b> Ancillary Items - Site General	<b>Risk Level:</b> L - Low Risk
<b>Manufacturer:</b> Owner/Operator	<b>Surface:</b> N/A

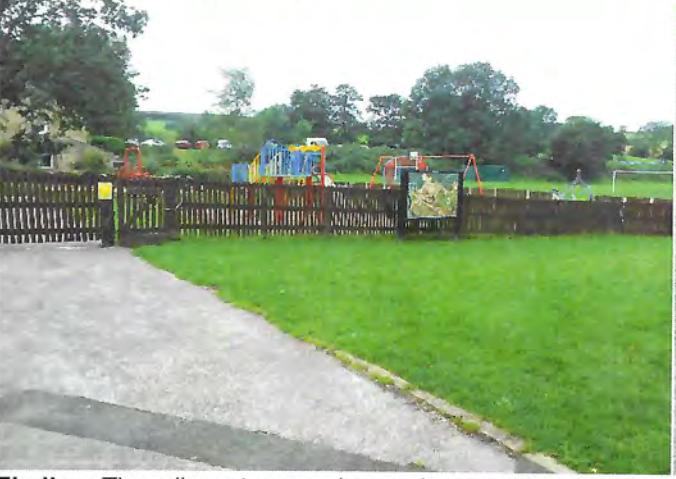
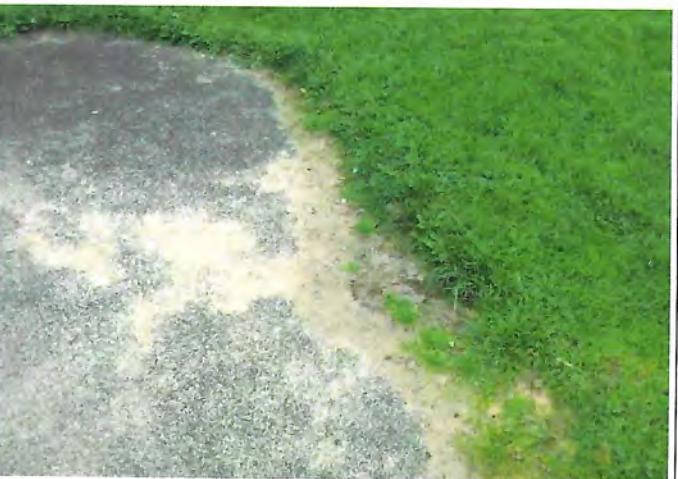
<b>Finding:</b> The adjacent grassed areas have encroached onto the impact attenuation surface	<b>Action:</b> Cut back and maintain the grass

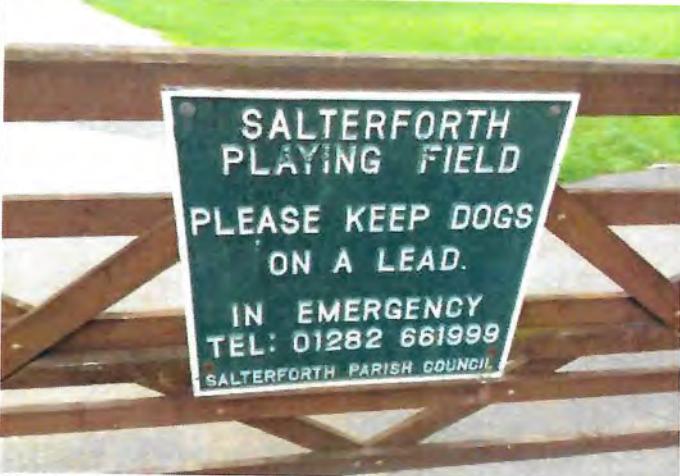
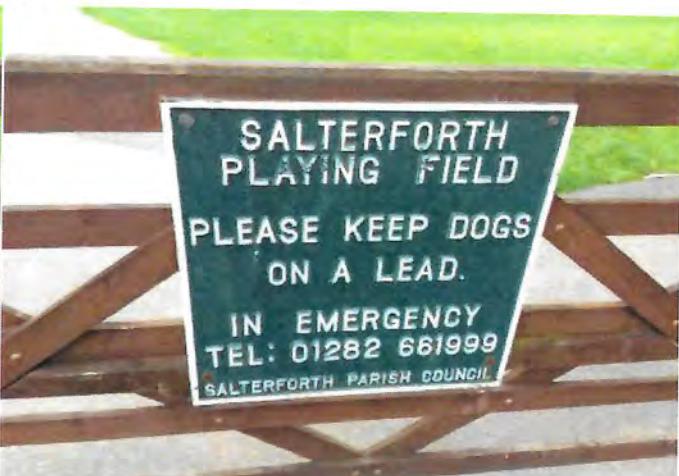
**Finding:** BS EN 1176 Part 7 recommends that signage shall include the site name / address  
**Action:** Provide additional information

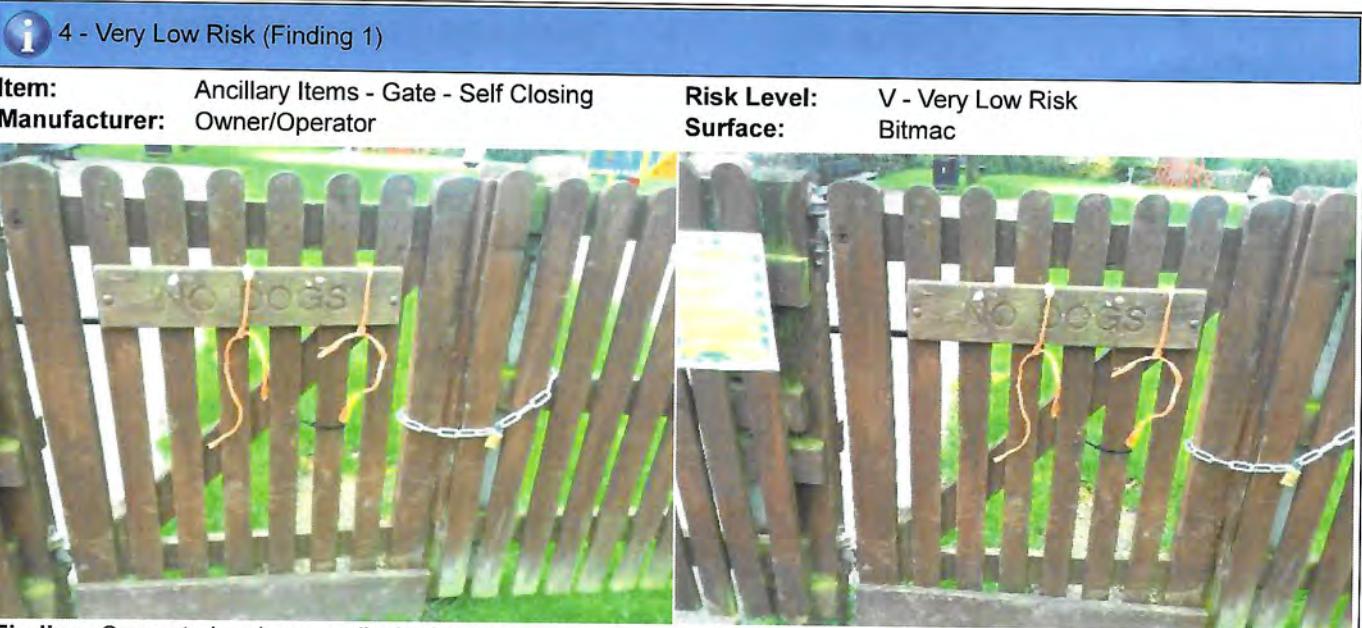
**Finding:** One gate has been padlocked shut

**Action:** Consider removing the padlock

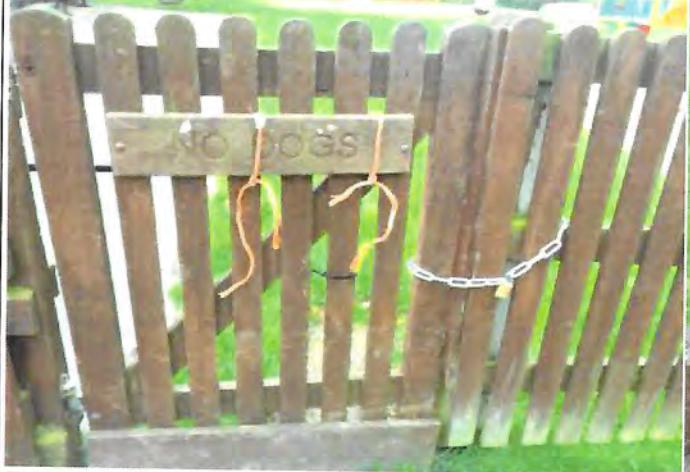
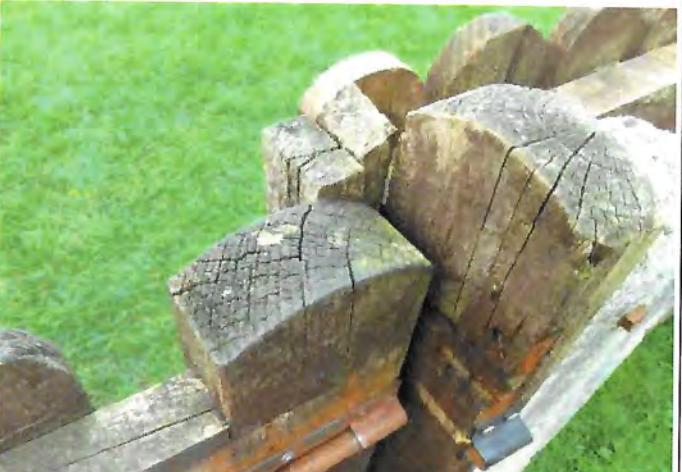
<b>Item:</b> Ancillary Items - Gate - Self Closing <b>Manufacturer:</b> Owner/Operator	<b>Risk Level:</b> L - Low Risk <b>Surface:</b> Bitmac
---	---

**Finding:** There are openings that are less than 12mm that could trap or crush fingers

**Action:** Where possible a 12mm gap should be maintained on both sides or between the gate leafs

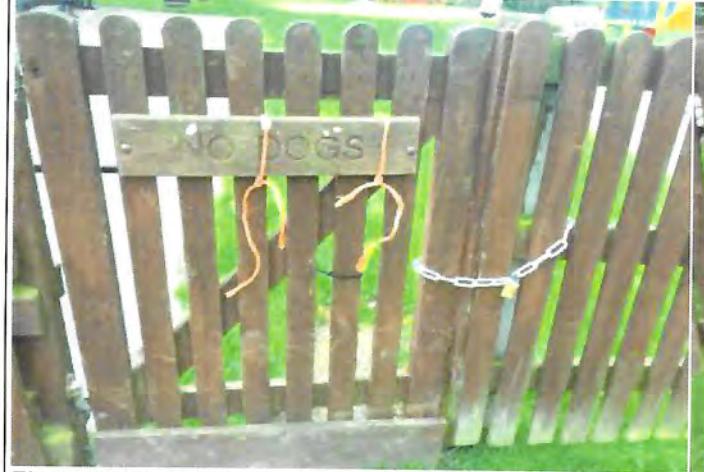
<b>Item:</b> Ancillary Items - Gate - Self Closing <b>Manufacturer:</b> Owner/Operator	<b>Risk Level:</b> L - Low Risk <b>Surface:</b> Bitmac
---	---

**Finding:** The gate is closing too quickly (less than 4 seconds)

**Action:** Take corrective action to ensure that the gate closes in 4-8 seconds

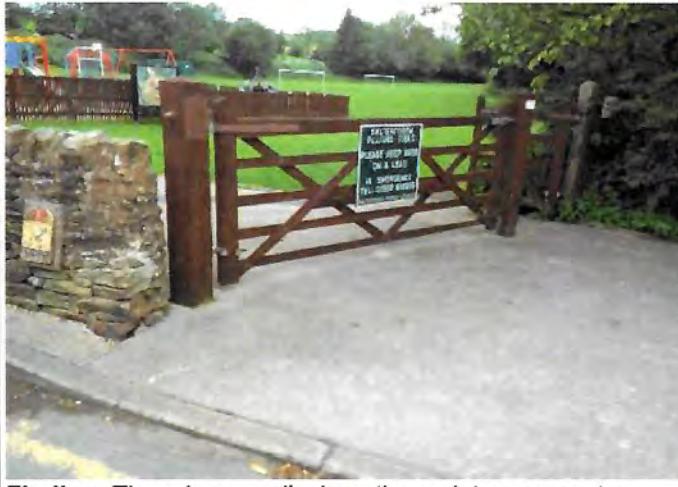
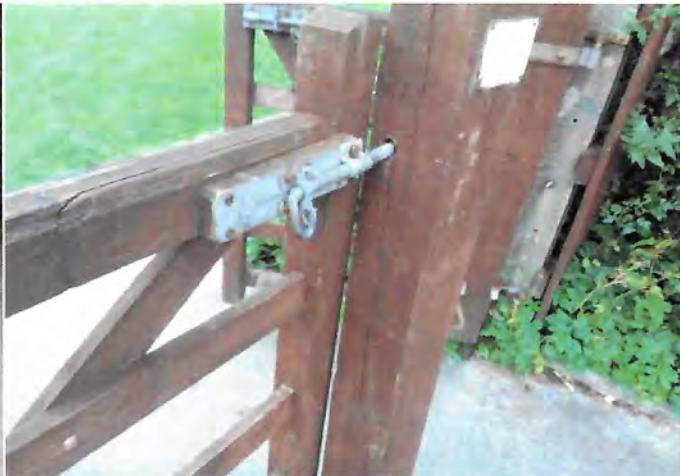
**Finding:** There is no padlock on the maintenance gate

**Action:** Provide a padlock to secure the gate

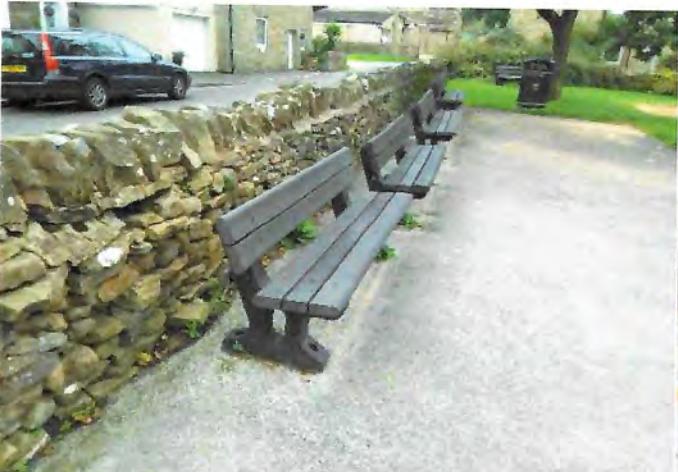
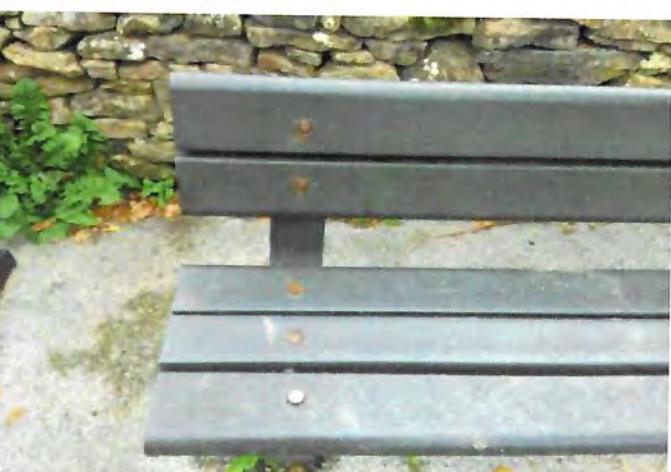
<b>Item:</b> Ancillary Items - Bench <b>Manufacturer:</b> Owner/Operator	<b>Risk Level:</b> V - Very Low Risk <b>Surface:</b> Bitmac
---	--

**Finding:** There is/are bolt cap covers missing or damaged on the item

**Action:** Replace missing or damaged bolt cap covers

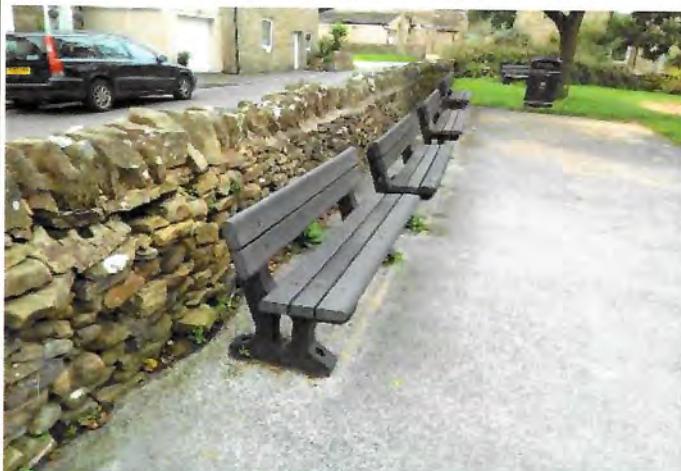
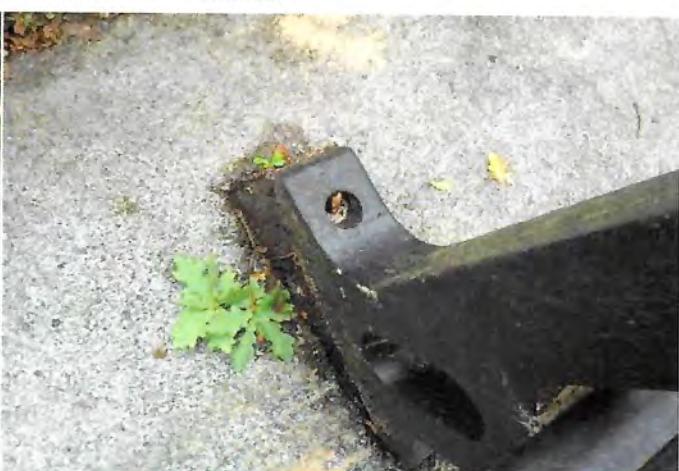
**Finding:** There is or are fixings missing on the bench and the bench can be lifted off the ground anchor bolts

**Action:** Replace all missing fixings

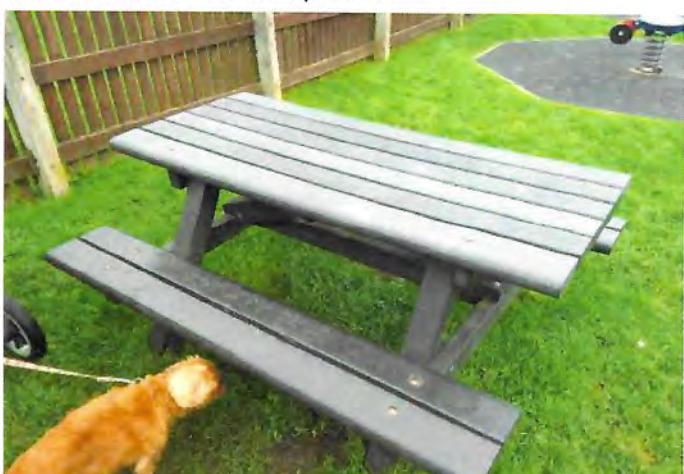
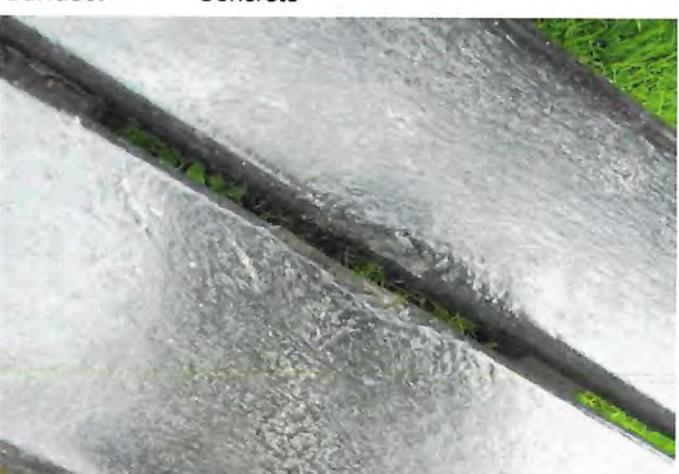
**Finding:** There is minor damage to the bench

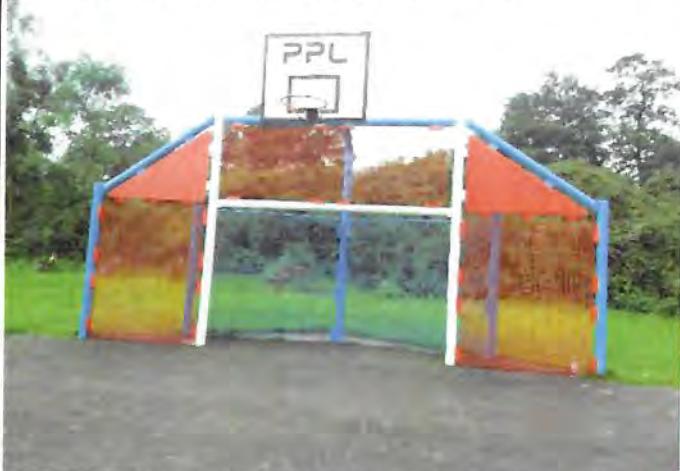
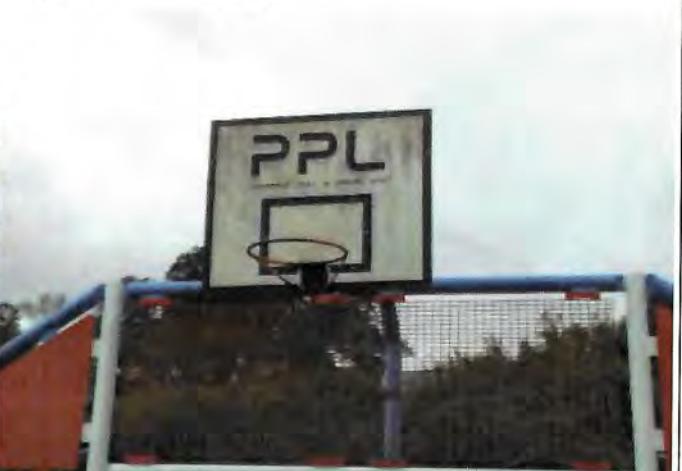
5 - Very Low Risk (Finding 1)			
<b>Item:</b>	Multi Use Games Area - Goalmouth and Basketball Post	<b>Risk Level:</b>	V - Very Low Risk
<b>Manufacturer:</b>	Parkdale Play & Leisure Ltd	<b>Surface:</b>	Tarmac

A close-up photograph of a basketball hoop. The backboard is white with the letters "PPL" printed on it. The hoop is mounted on a black pole.
<b>Finding:</b> A clearly visible facility sign should be provided in a prominent position with the wording as detailed BS EN 15312- the equipment is not intended for children less than 3 years old- the warning - Do not climb on the framework or nets- the warning - Do not hang on the ring (if provided)- the warning - Do not wear rings or other jewellery- name and telephone number of the administrator- number to call in case of accident			<b>Action:</b> Provide signage to BS EN 15312

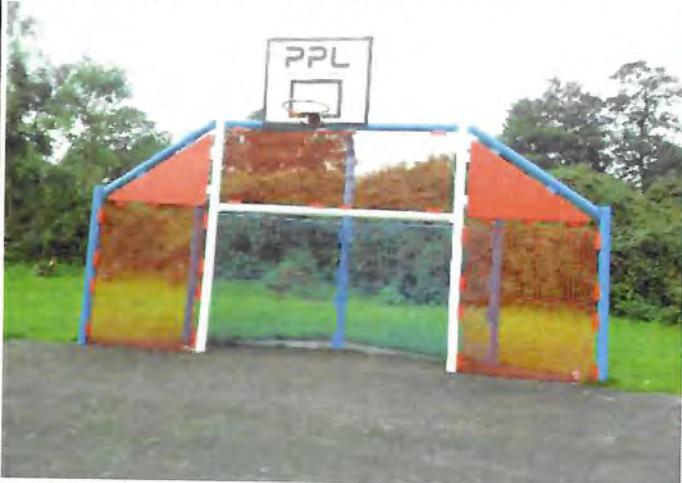
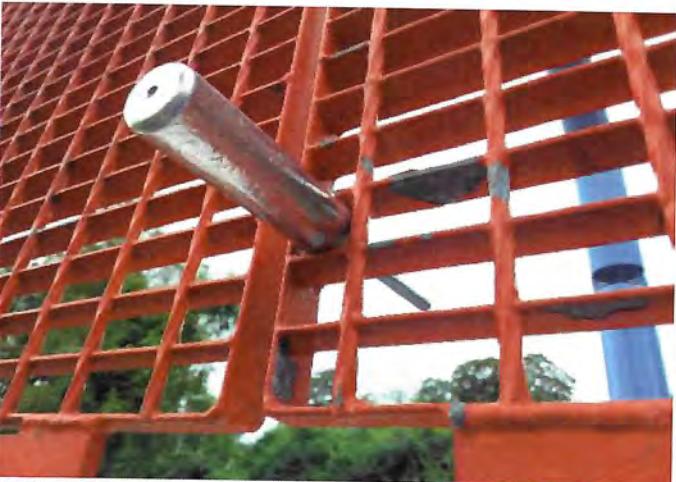
**Item:** Multi Use Games Area - Goalmouth and Basketball Post  
**Manufacturer:** Parkdale Play & Leisure Ltd

**Finding:** There is/are finger entrapments in the mesh openings and the item fails to meet the requirements of BS EN 15312 Clause 4.4.2.2 Entrapment of fingers

**Action:** Monitor - No remedial work recommended

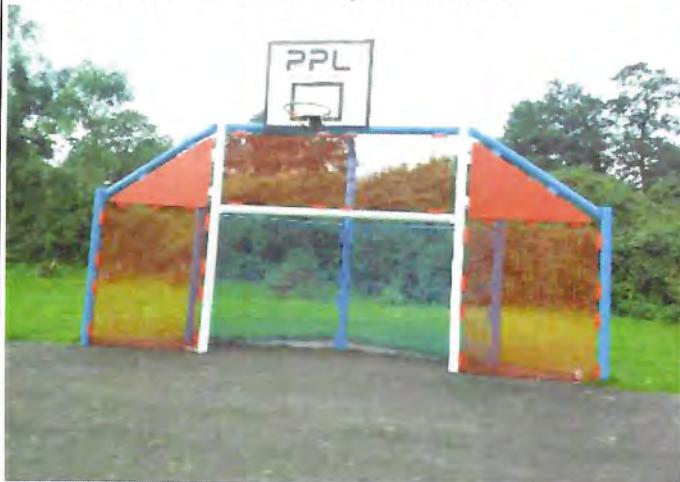
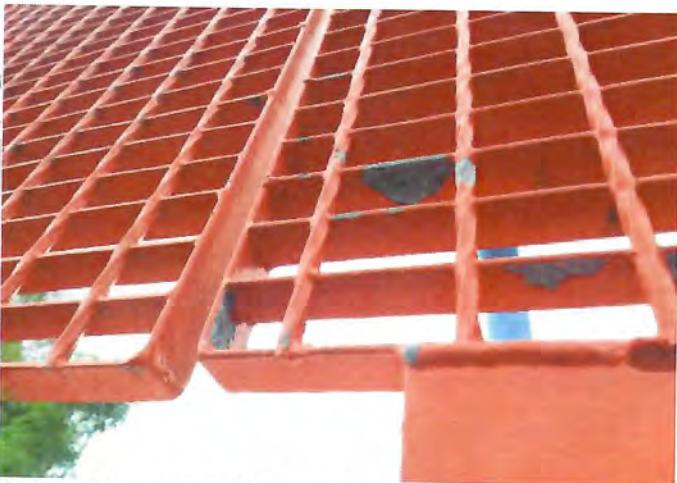
**Item:** Multi Use Games Area - Goalmouth and Basketball Post  
**Manufacturer:** Parkdale Play & Leisure Ltd

**Finding:** The paint is flaking off the metalwork

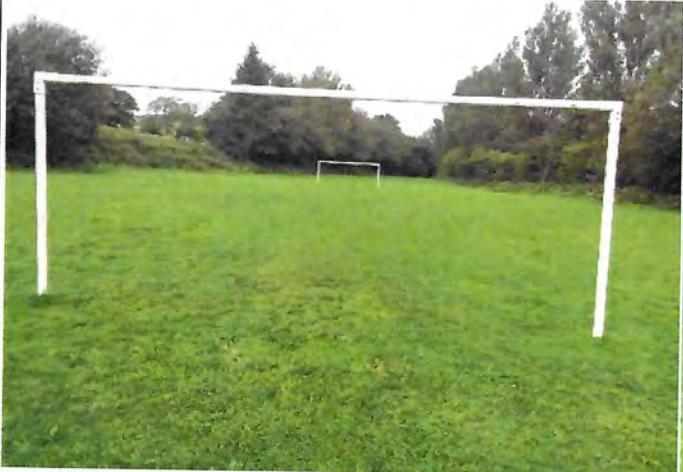
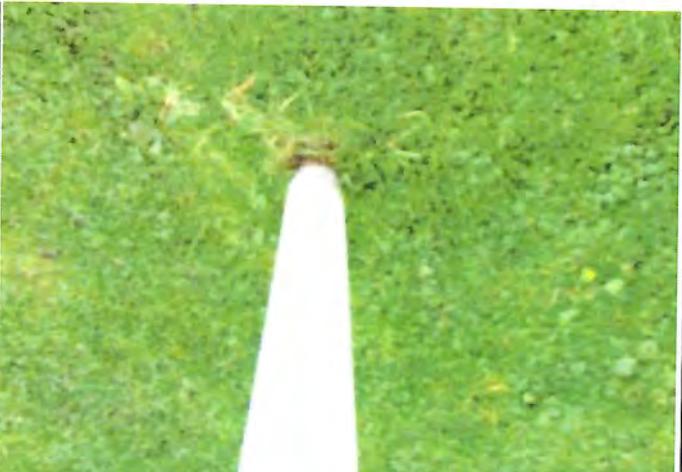
<b>Item:</b> Multi Use Games Area - Football Goal <b>Manufacturer:</b> Harrod	<b>Risk Level:</b> L - Low Risk <b>Surface:</b> Grass
--	--

**Finding:** The item is loose in its foundations

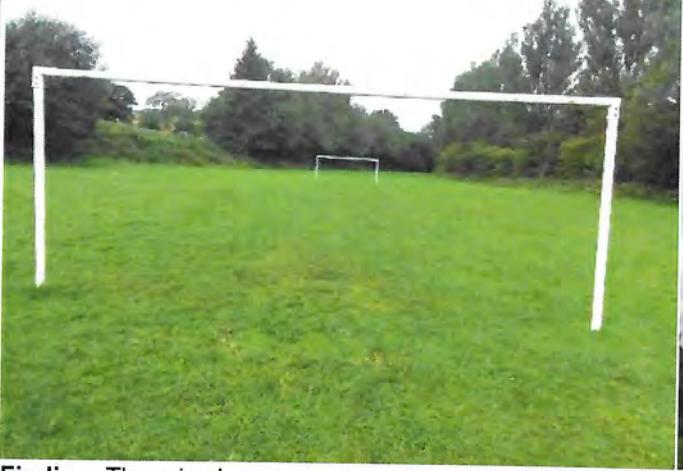
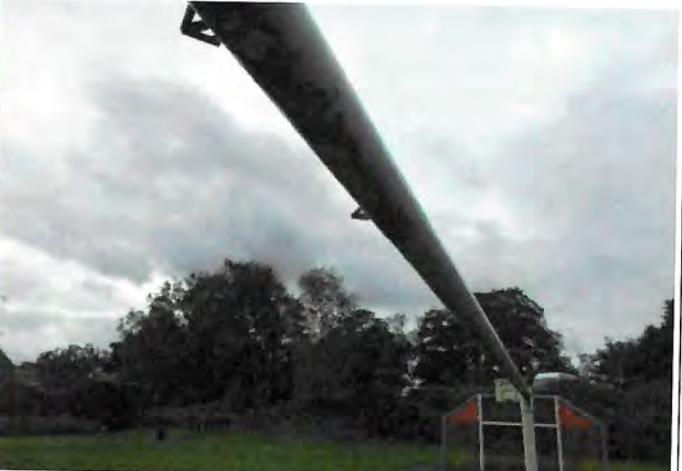
<b>Item:</b> Multi Use Games Area - Football Goal <b>Manufacturer:</b> Harrod	<b>Risk Level:</b> L - Low Risk <b>Surface:</b> Grass
--	--

**Finding:** There is algae or moss on the surface of the equipment

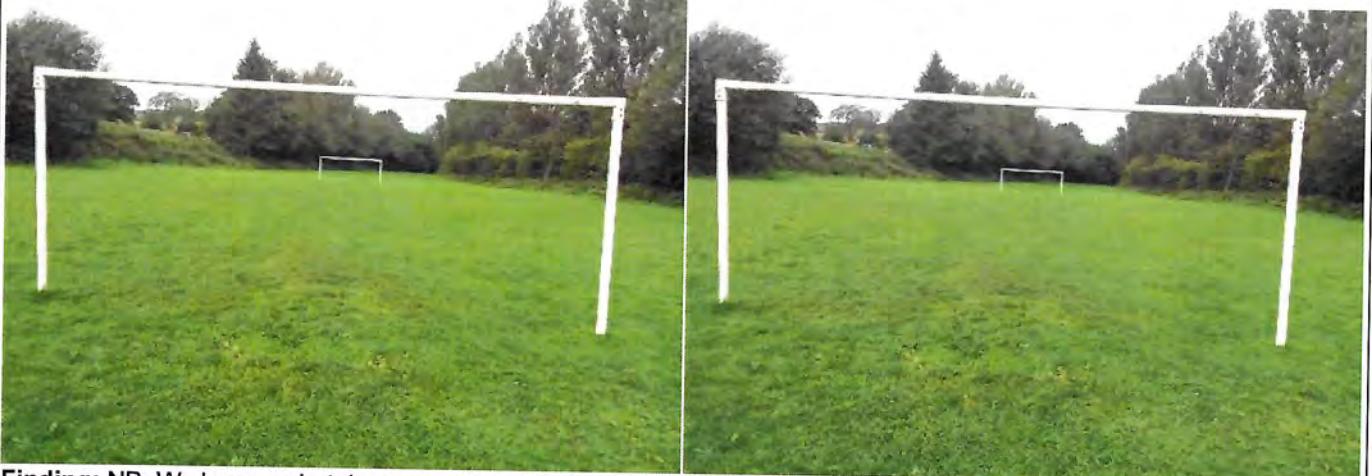
**Item:** Multi Use Games Area - Football Goal  
**Manufacturer:** Harrod      **Risk Level:** N - Risk Assessment not Undertaken  
**Surface:** Grass

**Finding:** NB: We have undertaken a maintenance inspection only of the football goal(s); full load testing falls outside the scope of our inspection.

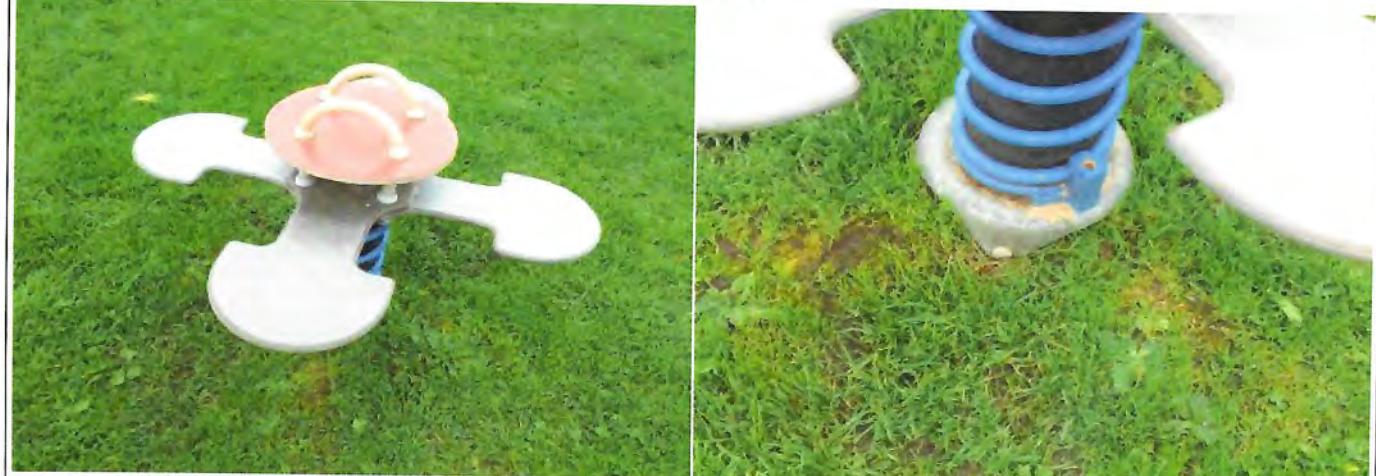
**Item:** Rocking Equipment - Spring Crazy Daisy  
**Manufacturer:** Not Identified      **Risk Level:** L - Low Risk  
**Surface:** Grass

**Finding:** The item is slightly loose in its foundations

**Action:** Monitor for any further deterioration and repair as required

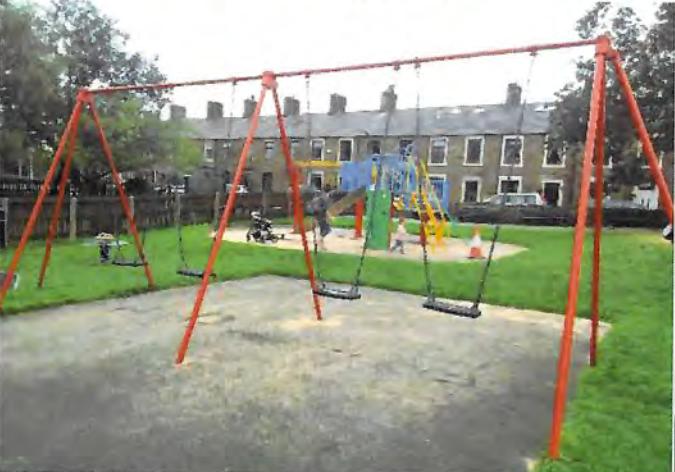
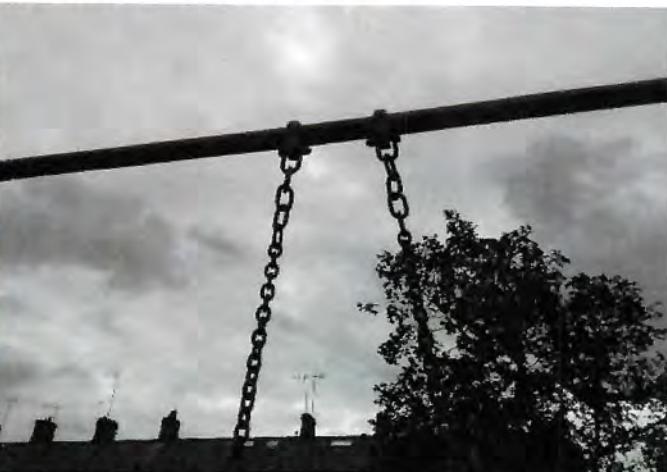
<b>Item:</b> Swings - 2 Bay 4 Seat (Flat) <b>Manufacturer:</b> Wicksteed Playgrounds	<b>Risk Level:</b> V - Very Low Risk <b>Surface:</b> Rubber Tiles
---	--

**Finding:** The bushes are showing signs of wear

**Action:** Monitor for any further deterioration and replace as required

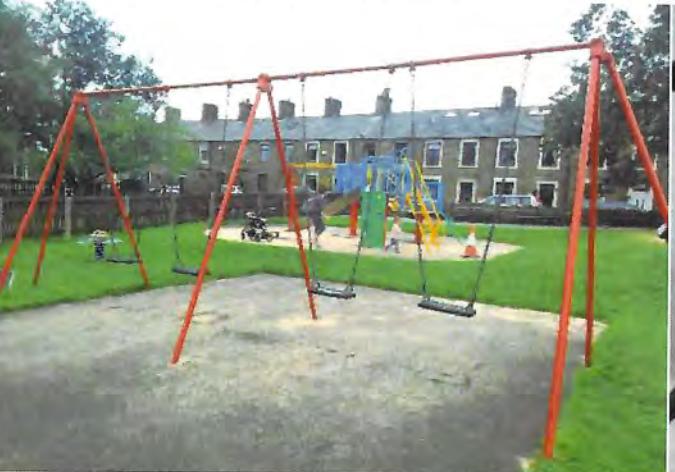
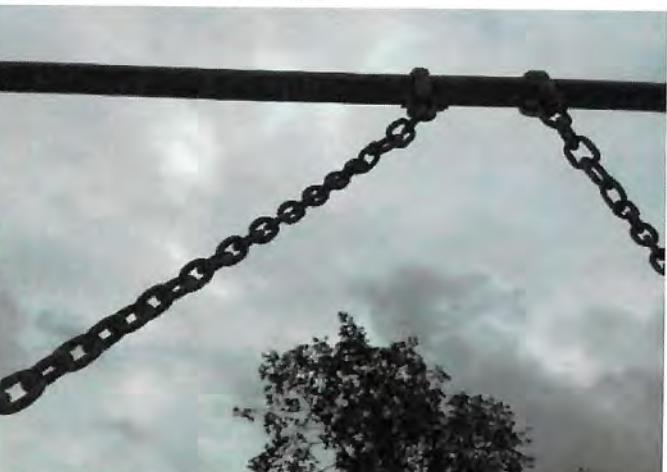
<b>Item:</b> Swings - 2 Bay 4 Seat (Flat) <b>Manufacturer:</b> Wicksteed Playgrounds	<b>Risk Level:</b> L - Low Risk <b>Surface:</b> Rubber Tiles
---	---

**Finding:** There is some wear to the shackles.

**Action:** Monitor for any further deterioration and replace when 40% worn

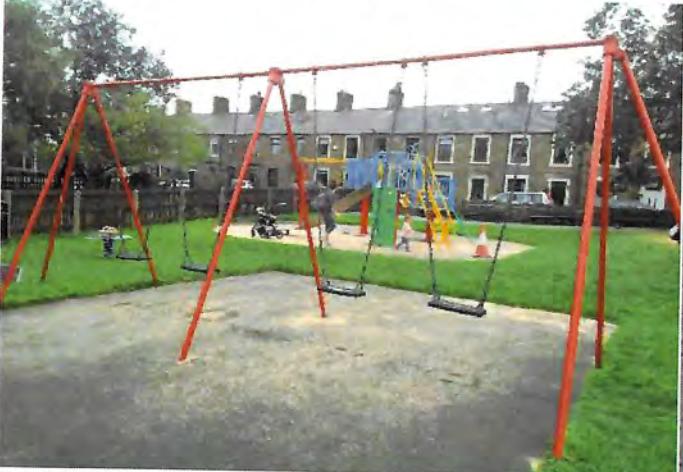
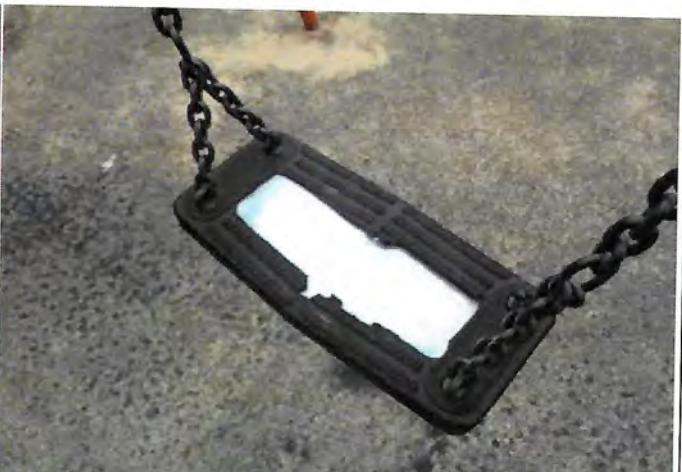
<b>Item:</b> Swings - 2 Bay 4 Seat (Flat) <b>Manufacturer:</b> Wicksteed Playgrounds	<b>Risk Level:</b> L - Low Risk <b>Surface:</b> Rubber Tiles
---	---

**Finding:** The seat is damaged and requires replacing

**Action:** Replace damaged seat

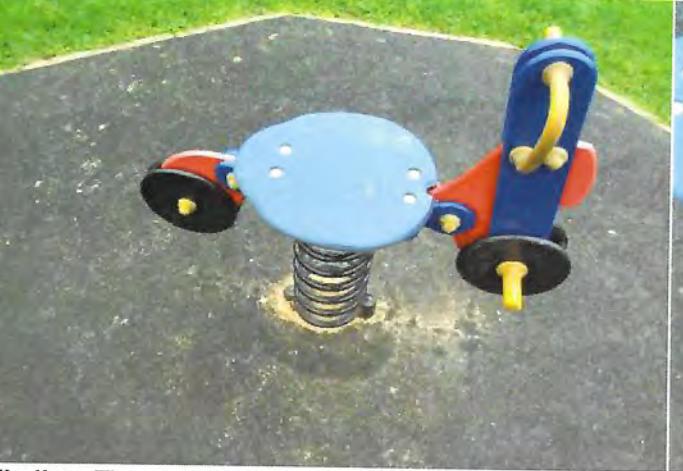
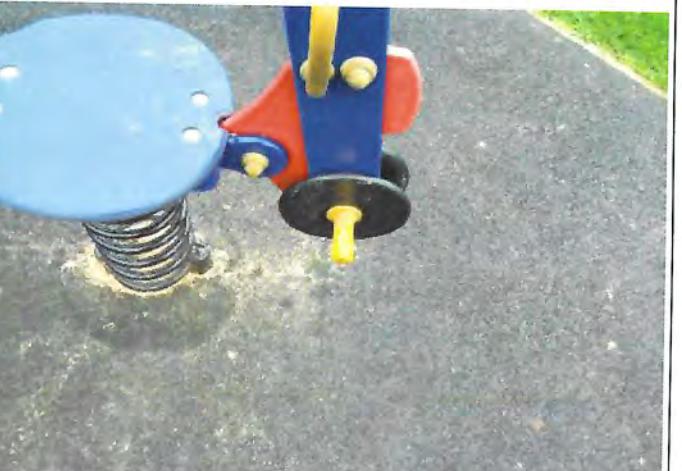
<b>Item:</b> Rocking Equipment - Spring Bike <b>Manufacturer:</b> Ledon	<b>Risk Level:</b> L - Low Risk <b>Surface:</b> Wet Pour
--	---

**Finding:** The end of handgrips and/or footrests have a cross section of less than 15cm<sup>2</sup> and fail to meet the requirements of BS EN 1176 Part 6

**Action:** Monitor - No remedial work recommended

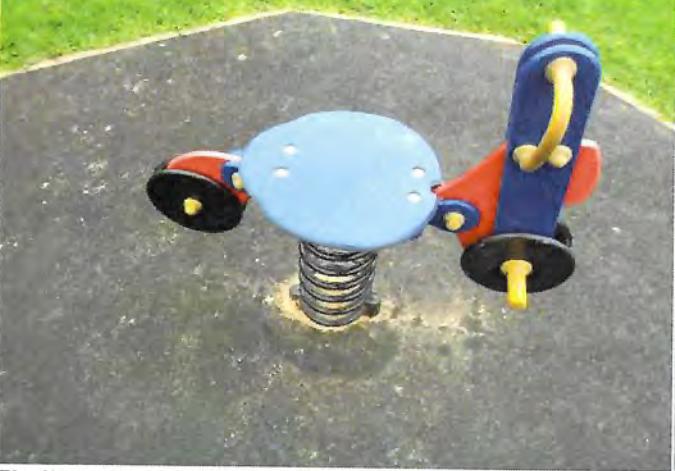
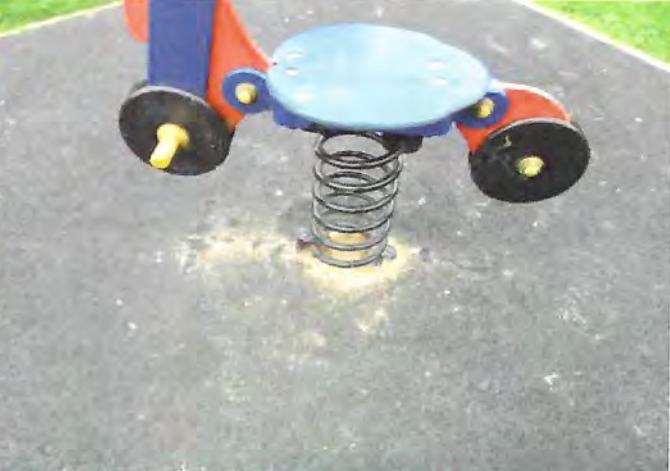
<b>Item:</b> Rocking Equipment - Spring Bike <b>Manufacturer:</b> Ledon	<b>Risk Level:</b> L - Low Risk <b>Surface:</b> Wet Pour
--	---

**Finding:** The paintwork on the spring has been damaged or **Action:** Treat any rusting components and repaint worn exposing the metal underneath which is rusting

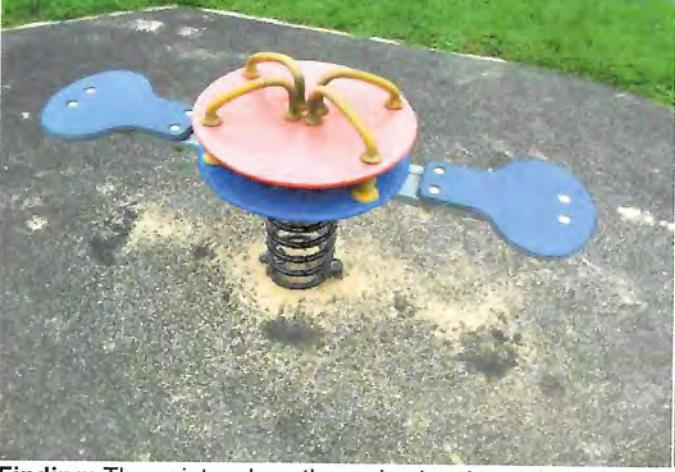
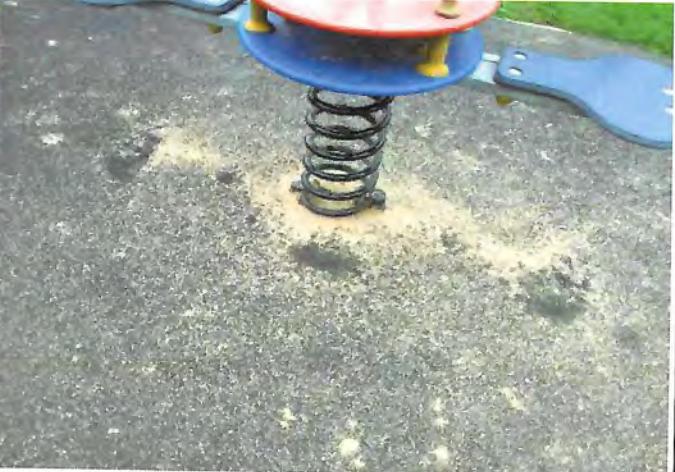
<b>Item:</b> Rocking Equipment - Spring See-Saw <b>Manufacturer:</b> Fahr Industries	<b>Risk Level:</b> L - Low Risk <b>Surface:</b> Wet Pour
---	---

**Finding:** The paintwork on the spring has been damaged or **Action:** Treat any rusting components and repaint worn exposing the metal underneath which is rusting

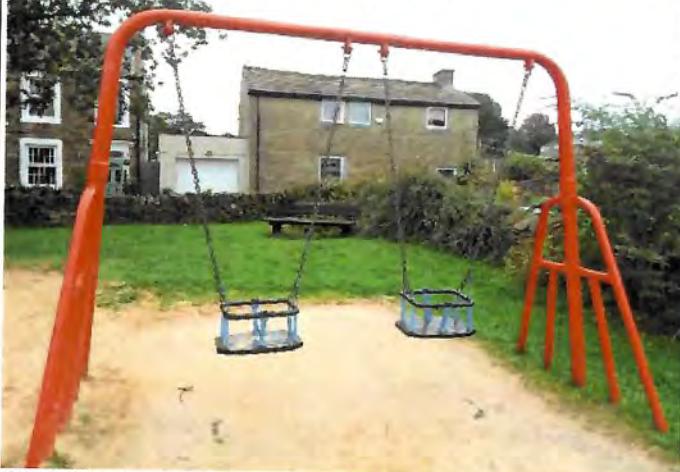
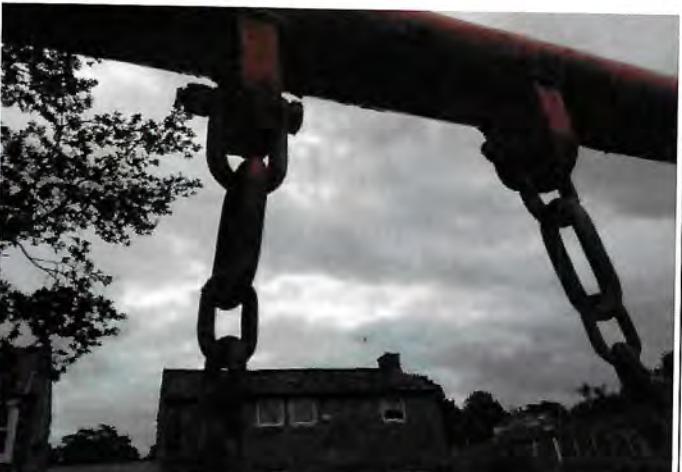
<b>Item:</b> Swings - 1 Bay 2 Seat (Cradle) <b>Manufacturer:</b> Wicksteed Playgrounds	<b>Risk Level:</b> V - Very Low Risk <b>Surface:</b> Wet Pour
---	--

**Finding:** The bushes are showing signs of wear

**Action:** Monitor for any further deterioration and replace as required

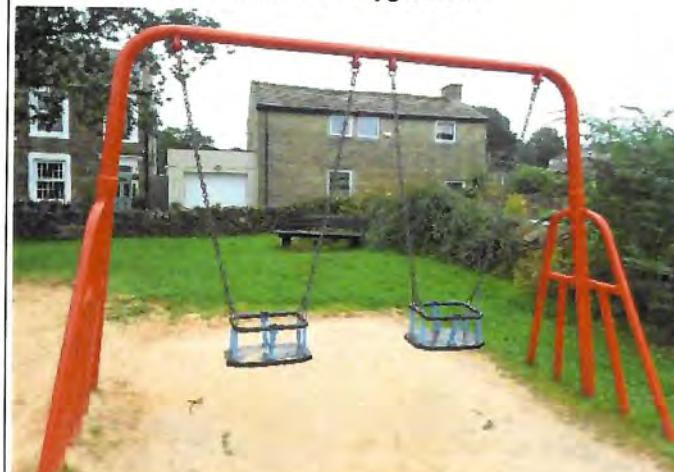
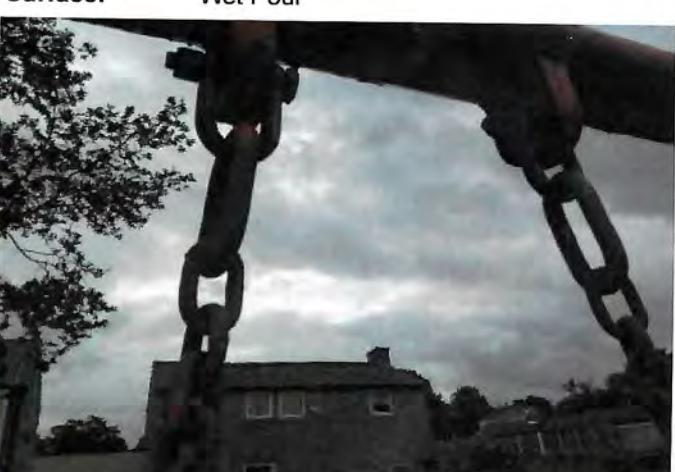
<b>Item:</b> Swings - 1 Bay 2 Seat (Cradle) <b>Manufacturer:</b> Wicksteed Playgrounds	<b>Risk Level:</b> L - Low Risk <b>Surface:</b> Wet Pour
---	---

**Finding:** There is some wear to the shackles.

**Action:** Monitor for any further deterioration and replace when 40% worn

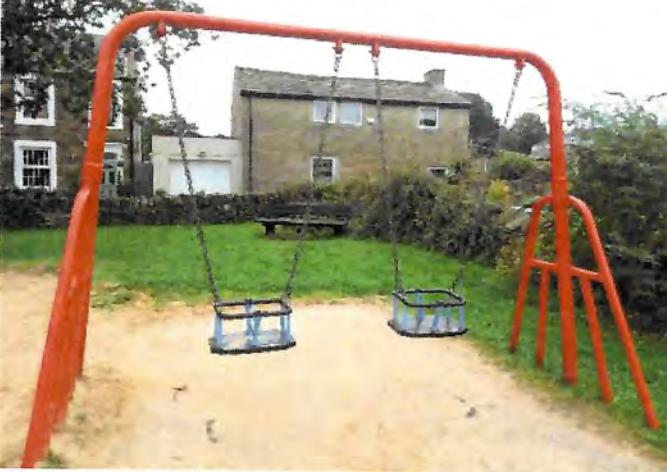
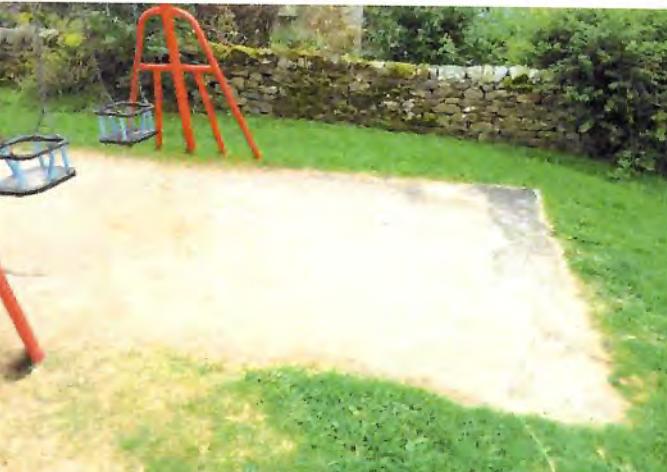
5 - Very Low Risk (Finding 3)	
<b>Item:</b> Swings - 1 Bay 2 Seat (Cradle) <b>Manufacturer:</b> Wicksteed Playgrounds	<b>Risk Level:</b> V - Very Low Risk <b>Surface:</b> Wet Pour

<b>Finding:</b> The surfacing dimensions are short and do not meet with the requirements of the current applicable standard	<b>Action:</b> Monitor - no remedial action recommended
6 - Low Risk (Finding 1)	
<b>Item:</b> Activity Equipment - Sand Box <b>Manufacturer:</b> Not Identified	<b>Risk Level:</b> L - Low Risk <b>Surface:</b> Sand

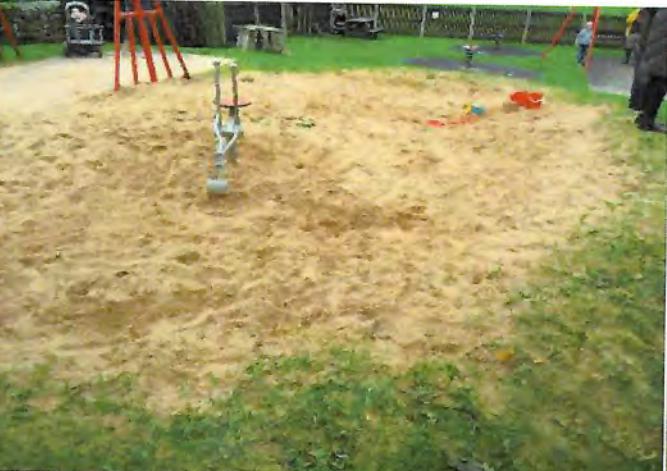
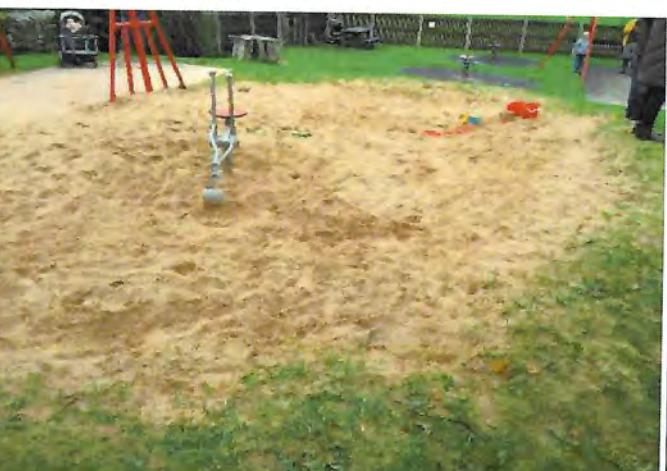
<b>Finding:</b> Sand is migrating to adjacent surfaces	<b>Action:</b> Provide appropriate sand retention

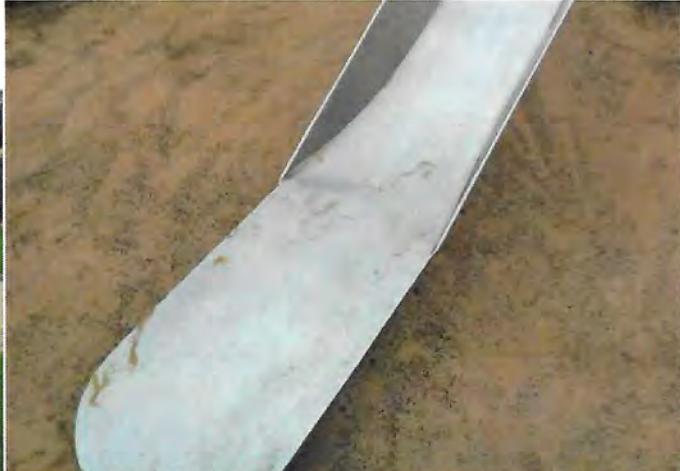
**Finding:** There are a number of dents in the slide surface

**Action:** Monitor for any further deterioration and repair as required

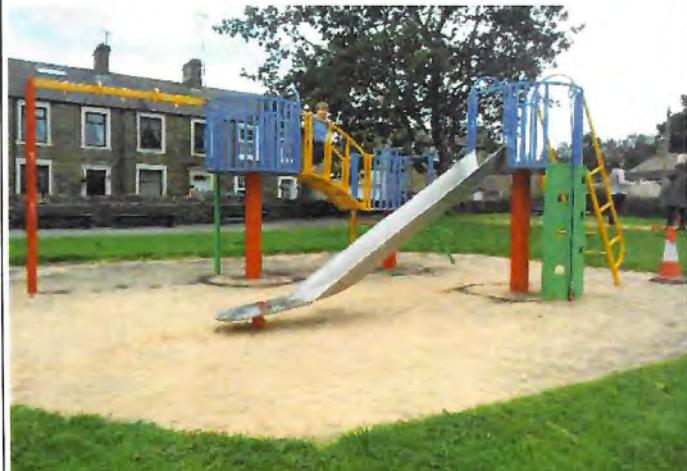
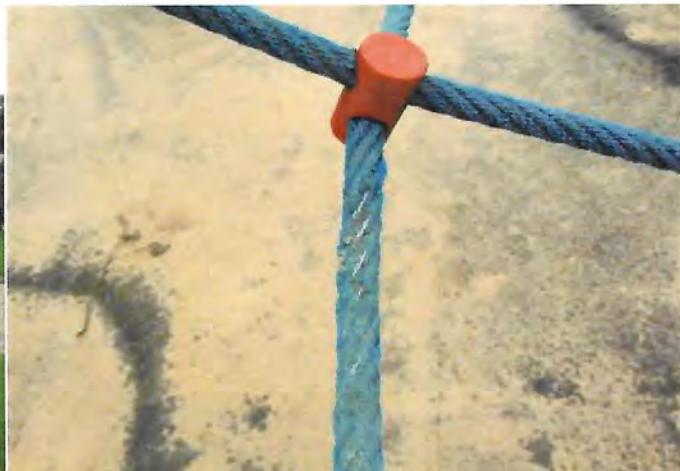
**Item:** Activity Equipment - Multi Play (Junior)  
**Manufacturer:** Parkdale Play & Leisure Ltd

**Finding:** The ropes/nets are worn/damaged in places

**Action:** Monitor for any further deterioration and repair or replace as required

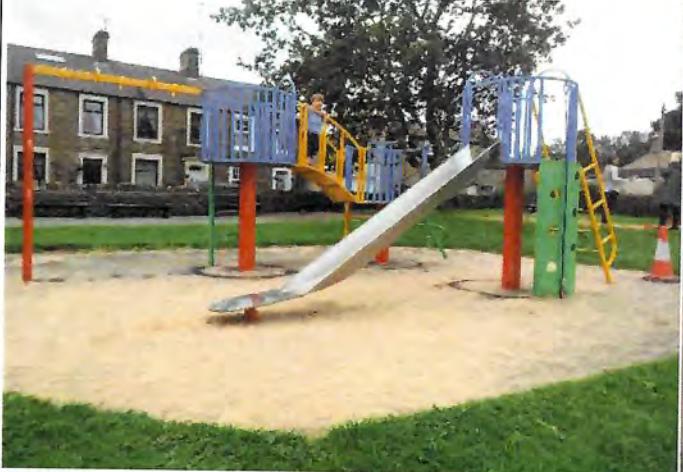
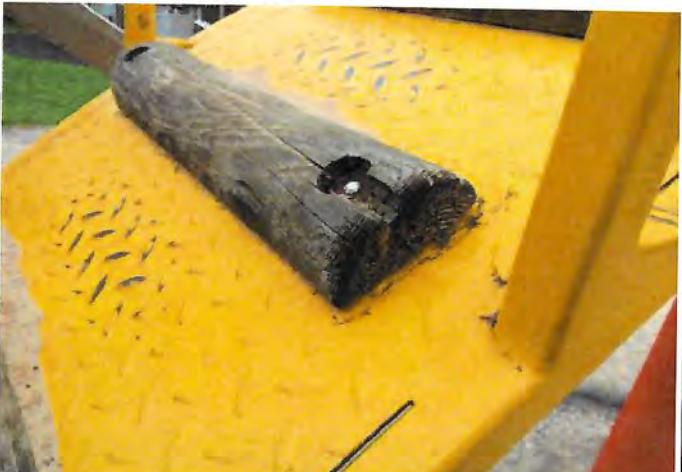
<b>Item:</b> Activity Equipment - Multi Play (Junior) <b>Manufacturer:</b> Parkdale Play & Leisure Ltd	<b>Risk Level:</b> L - Low Risk <b>Surface:</b> Wet Pour
---	---

**Finding:** There is some evidence of rot in the timber

**Action:** Monitor for any further deterioration and replace as required

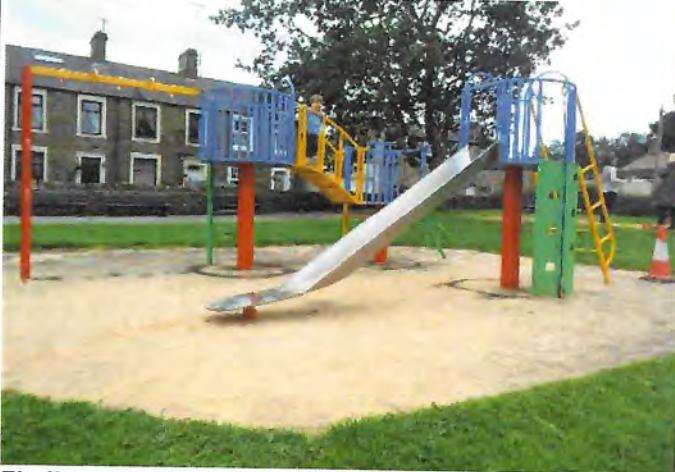
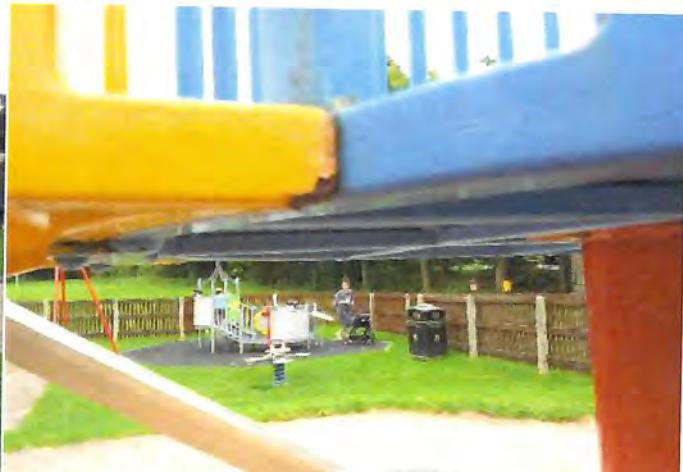
<b>Item:</b> Activity Equipment - Multi Play (Junior) <b>Manufacturer:</b> Parkdale Play & Leisure Ltd	<b>Risk Level:</b> L - Low Risk <b>Surface:</b> Wet Pour
---	---

**Finding:** The paintwork on this item has been damaged or worn exposing the metal underneath which is rusting

**Action:** Treat any rusting components and repaint

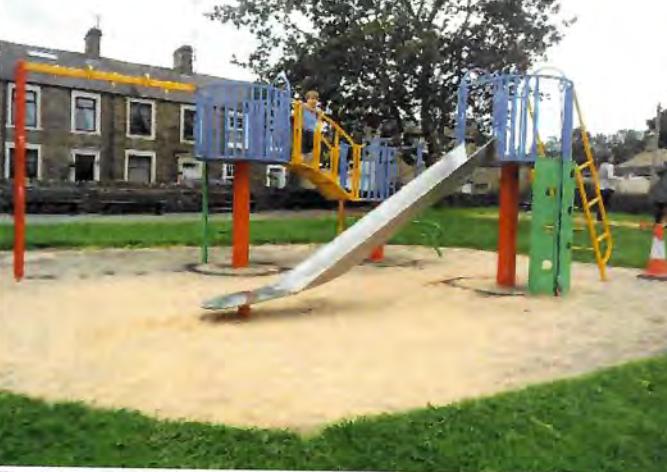
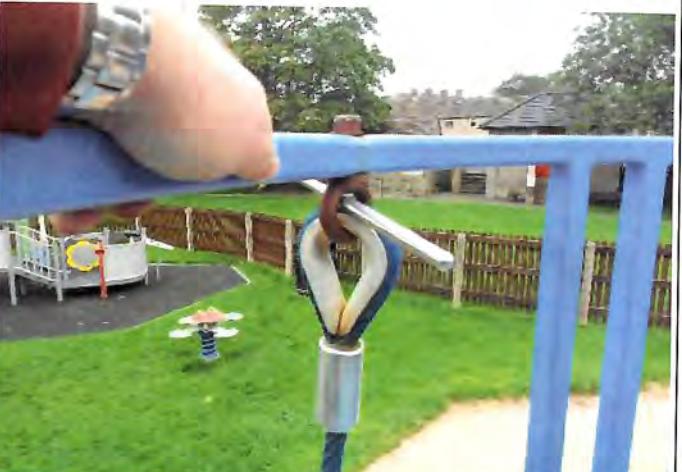
<b>Item:</b> Activity Equipment - Multi Play (Junior) <b>Manufacturer:</b> Parkdale Play & Leisure Ltd	<b>Risk Level:</b> V - Very Low Risk <b>Surface:</b> Wet Pour
---	--

**Finding:** The connecting links are in excess of 8.6mm and less than 12mm and fail the requirements of BS EN 1176 Part 1; clause 4.2.13, Chains

**Action:** Monitor use and replace with compliant links at the next maintenance cycle
