# the play inspection company

## Annual Inspection

Pendle Borough Council

Salterforth

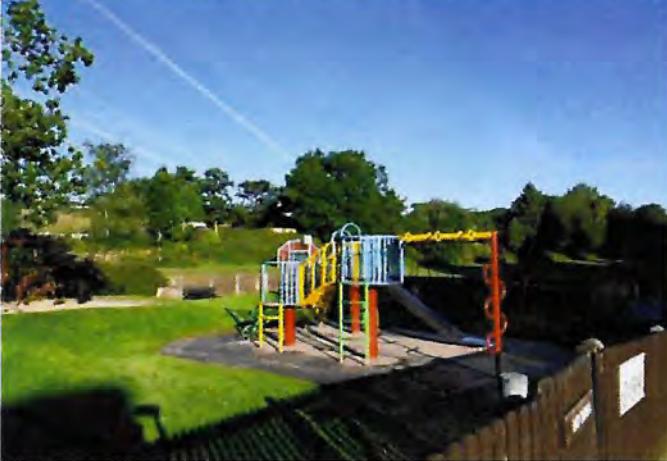
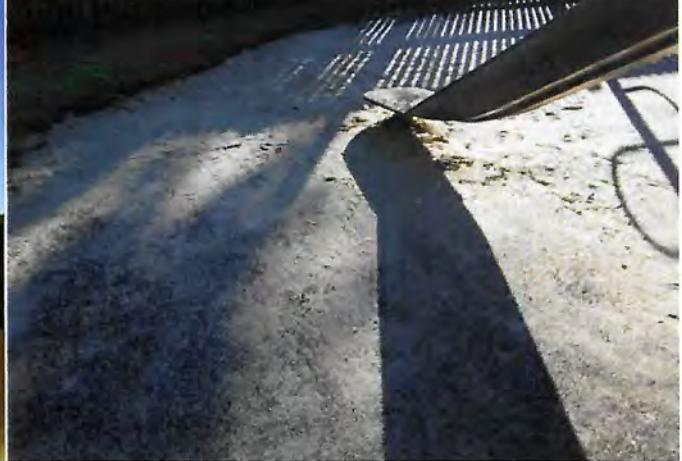
<b>Finding:</b> Sand has migrated on to the playing surfaces	
<b>Action:</b> Remove and maintain

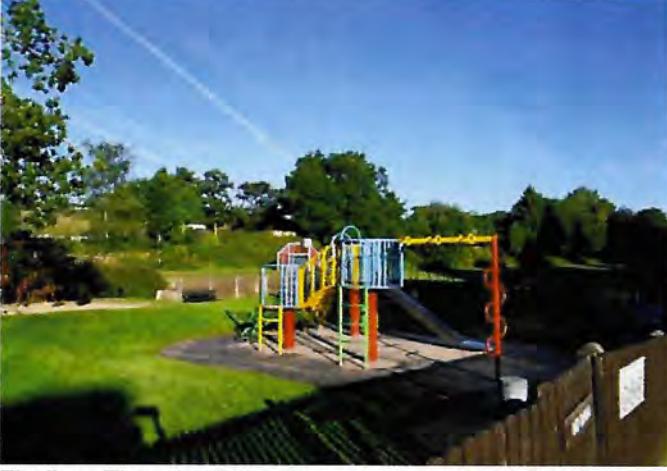
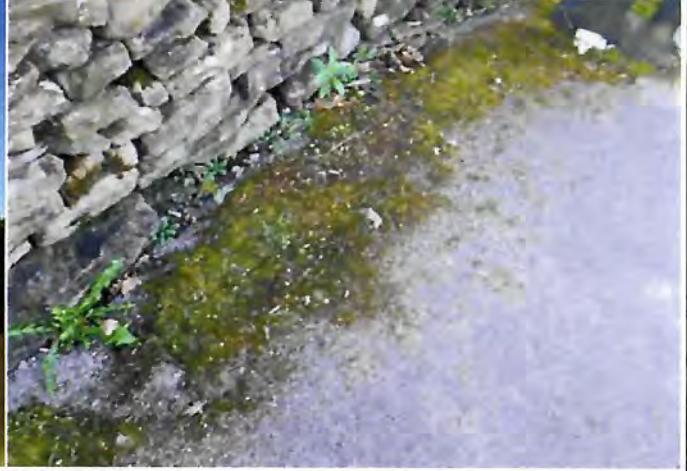
**Finding:** There is algae, silt or moss growth on the surface resulting in slippery conditions    **Action:** Clean and treat appropriately

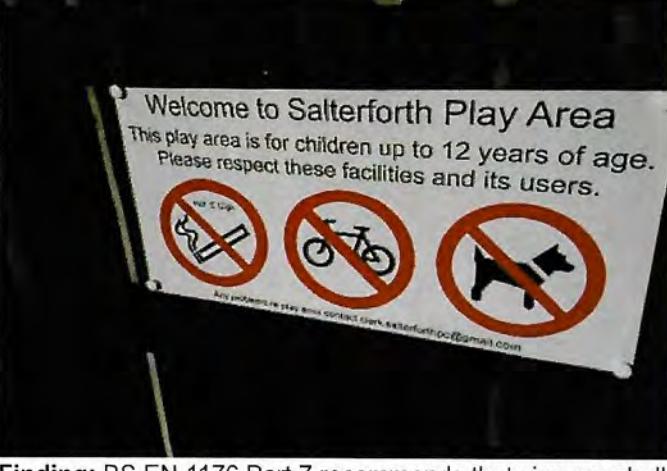
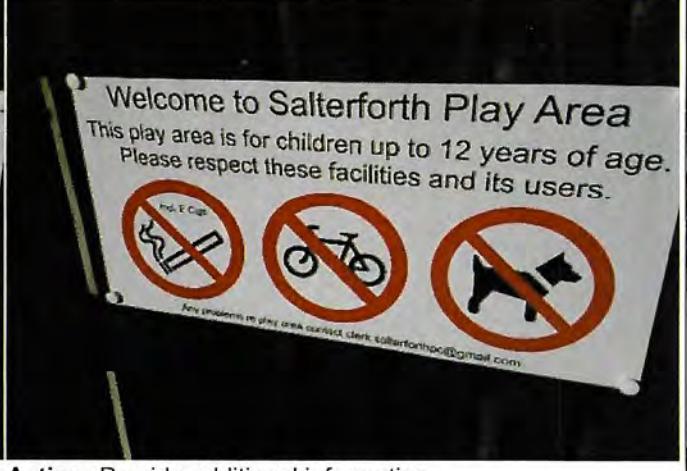
**Finding:** BS EN 1176 Part 7 recommends that signage shall include emergency contact details and contact details of owner / operator for reporting maintenance issues    **Action:** Provide additional information

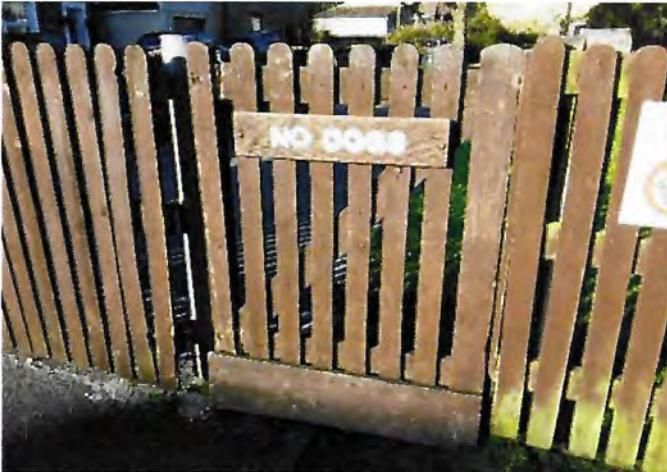
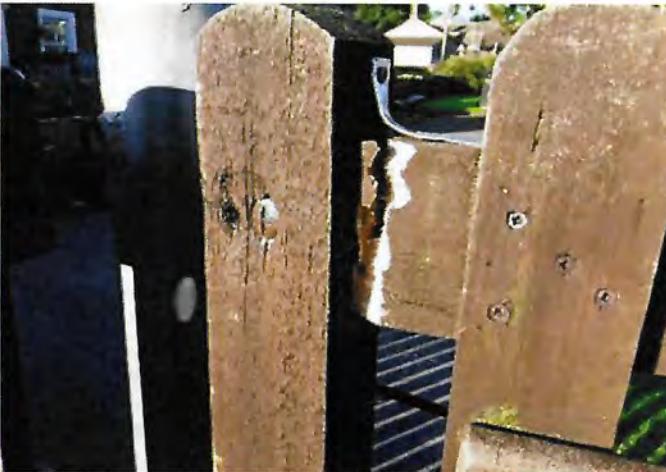
**Finding:** There is some damage to the item

**Action:** Monitor for any further deterioration and repair as required

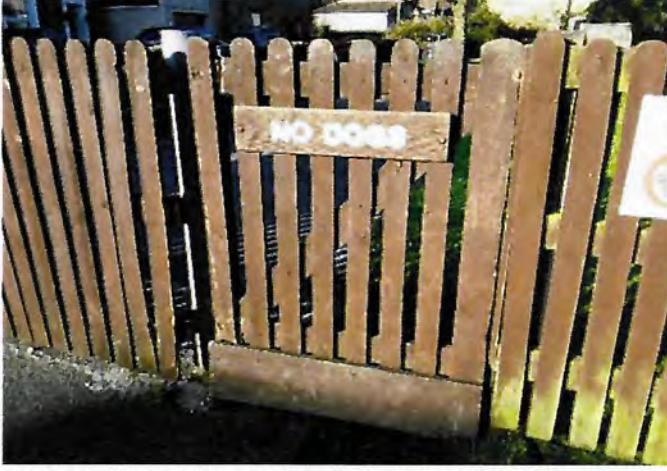
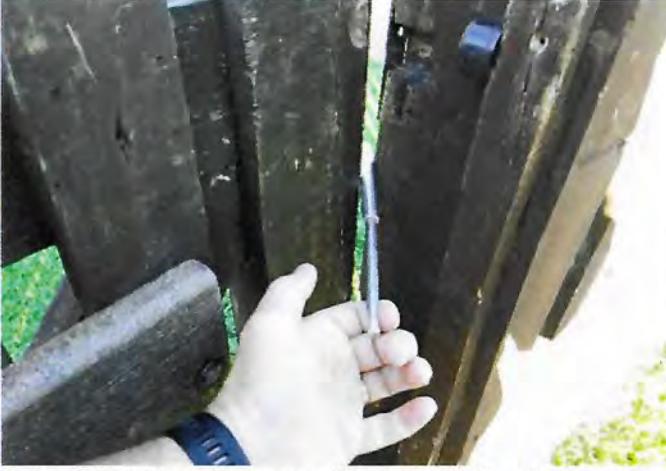
**Finding:** There are openings that are less than 12mm that could trap or crush fingers

**Action:** Provide a 12mm gap throughout full range of motion at both sides of gate

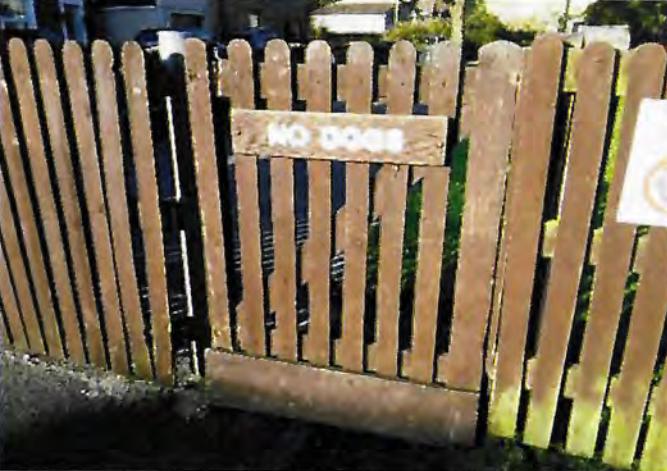
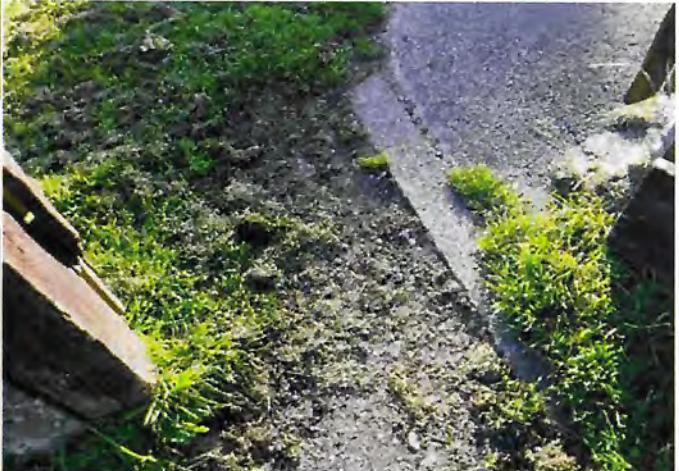
<b>Finding:</b> The area under the gate has eroded leaving uneven areas, or the concrete foundations exposed, resulting in trip hazards at the entrance/exit to the playground	
<b>Action:</b> Reinstate to level with surrounding surfaces	
0 - Risk Assessment not Undertaken (Finding 1)	
<b>Item:</b> Gates - Gate - Maintenance	<b>Risk Level:</b> N - Risk Assessment not Undertaken
<b>Manufacturer:</b> Not Identified	<b>Surface:</b> Bitmac

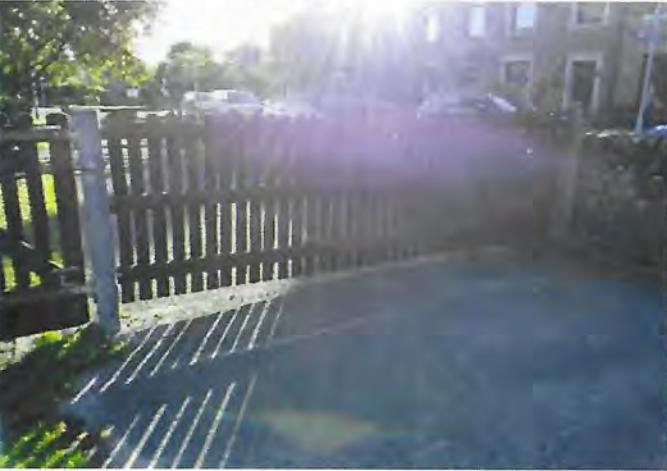
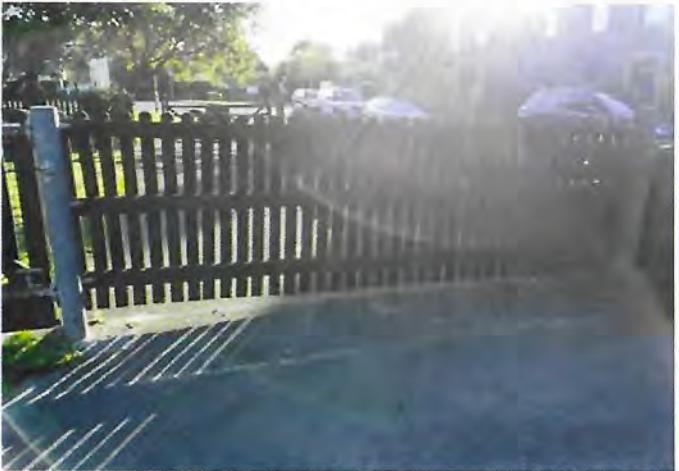
<b>Finding:</b> The maintenance gate was correctly padlocked at the time of inspection, however this means that the inspector full range of motion on gate/s and between leaves where was unable to fully assess the gate	
<b>Action:</b> Ensure that there are 12mm gaps throughout the full range of motion on gate/s and between leaves where relevant

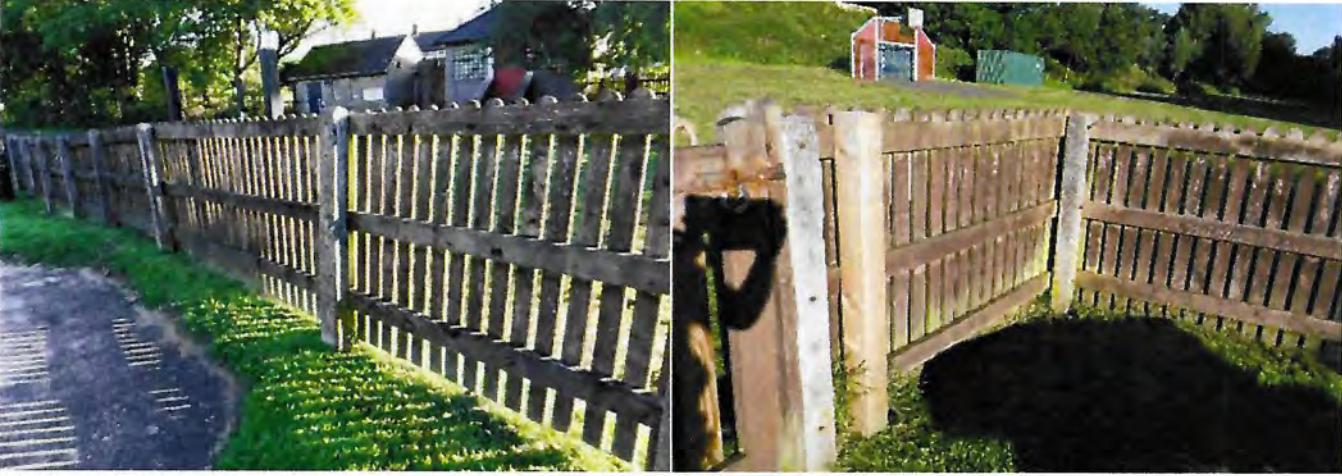
**Finding:** There are a number of loose posts around the fence

**Action:** Monitor for any further deterioration and reset as required

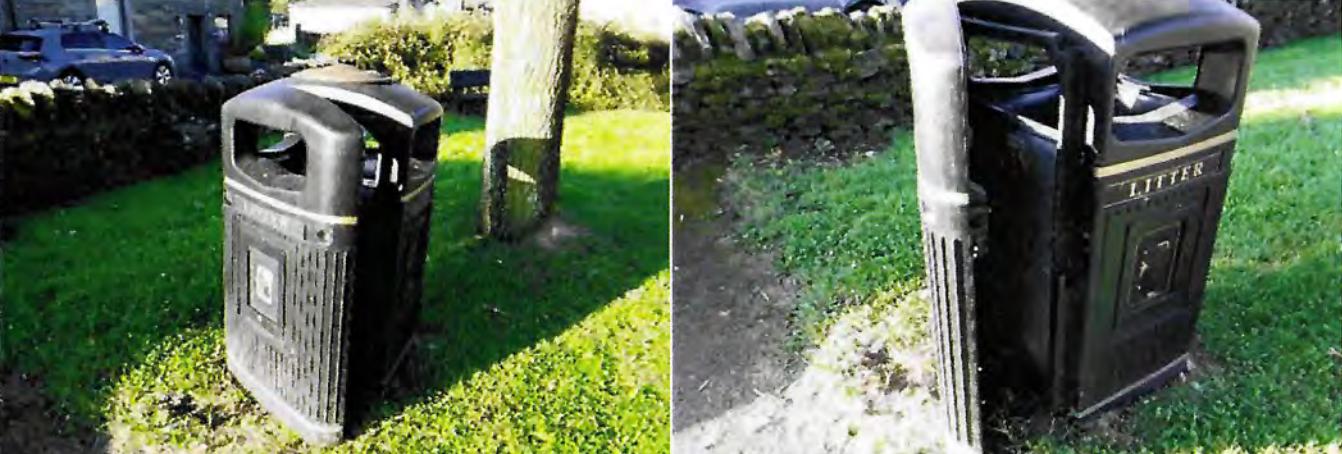
**Finding:** The lid or door of the litter bin is not secured

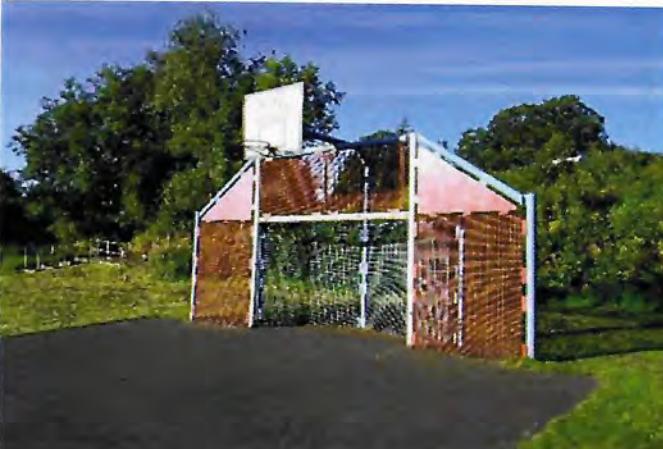
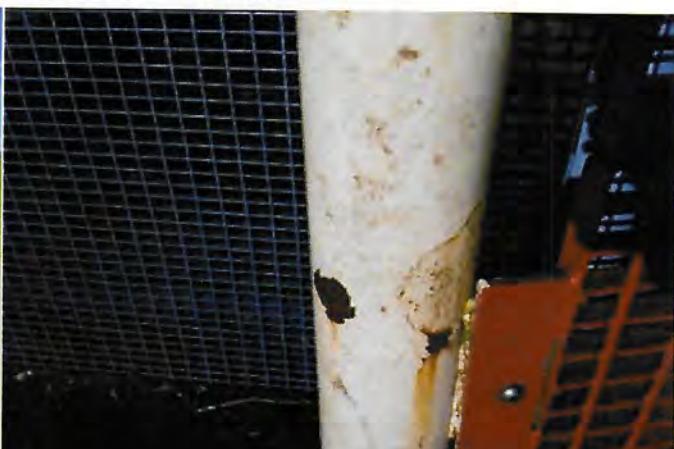
**Finding:** The paintwork on this item has been damaged or worn exposing the metal underneath which is rusting / corroding

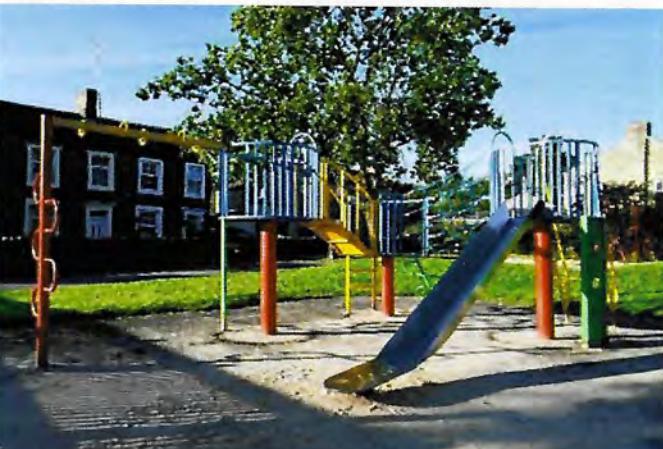
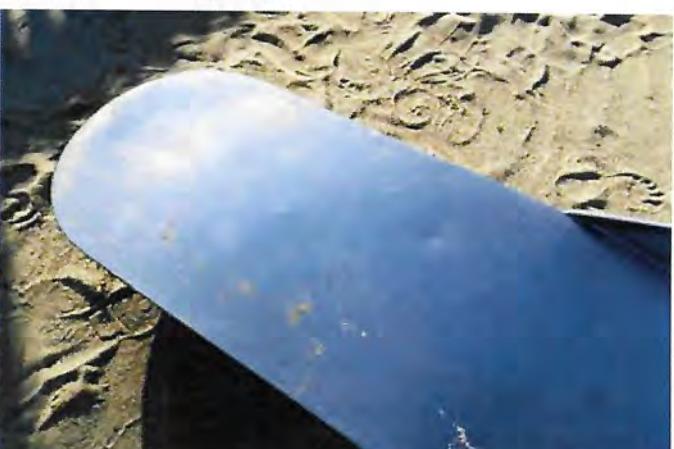
**Finding:** There are a number of dents in the slide surface

**Action:** Monitor for any further deterioration and repair as required

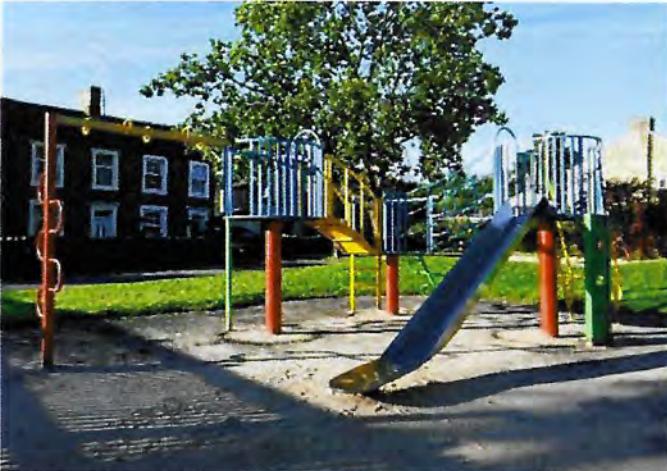
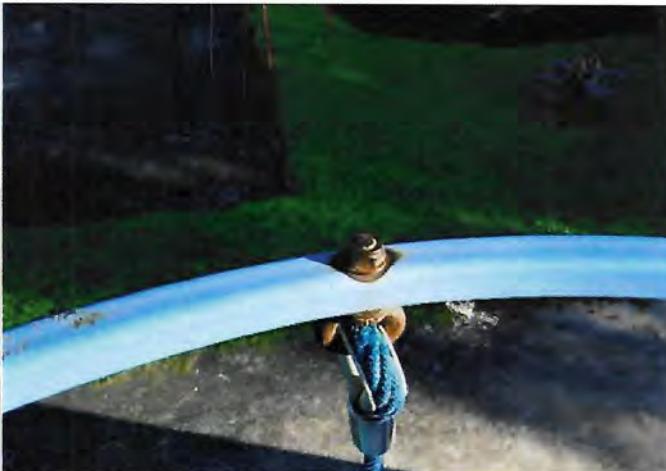
**Finding:** There is/are bolt cap covers missing or damaged on the item

**Action:** Replace missing or damaged bolt cap covers

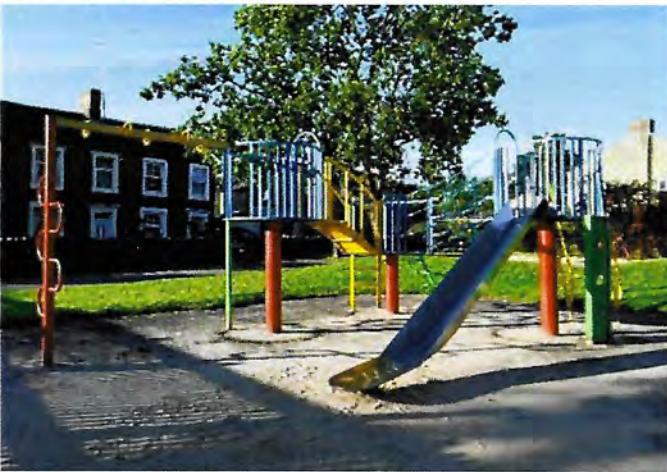
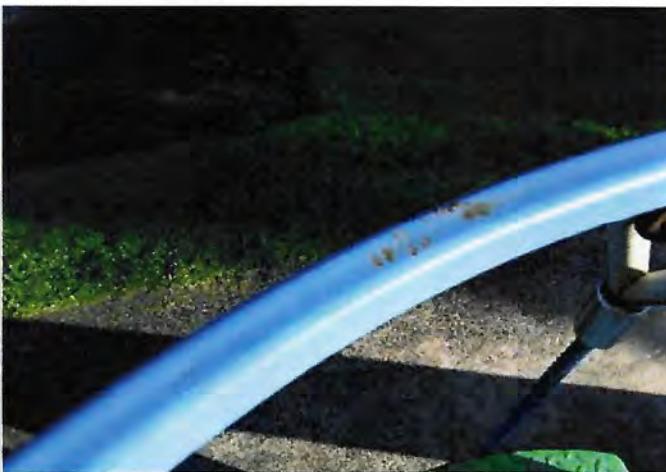
**Finding:** The paintwork on this item has been damaged or worn exposing the metal underneath which is rusting / corroding

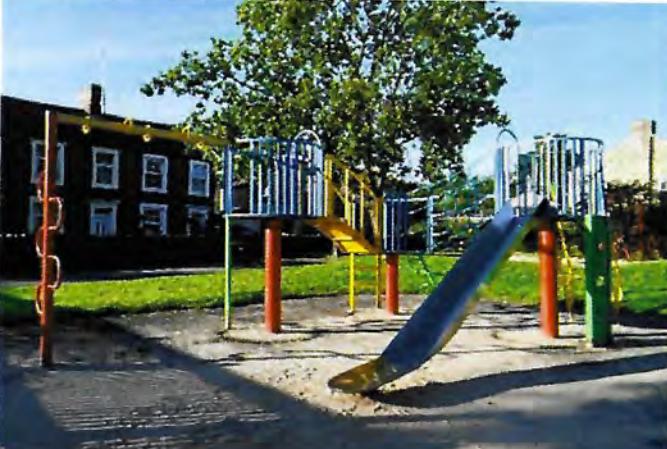
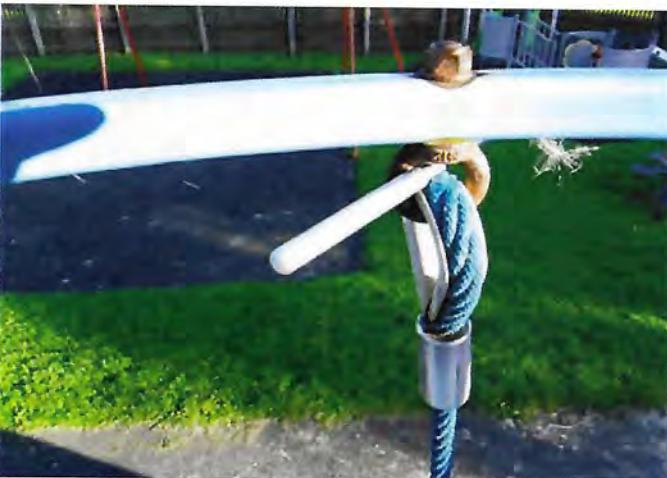
<b>Finding:</b> The connecting links are in excess of 8.6mm and less than 12mm and fail the requirements of BS EN 1176 Part 1; clause 4.2.13, Chains	<b>Action:</b> Monitor use and replace with compliant links at the next maintenance cycle

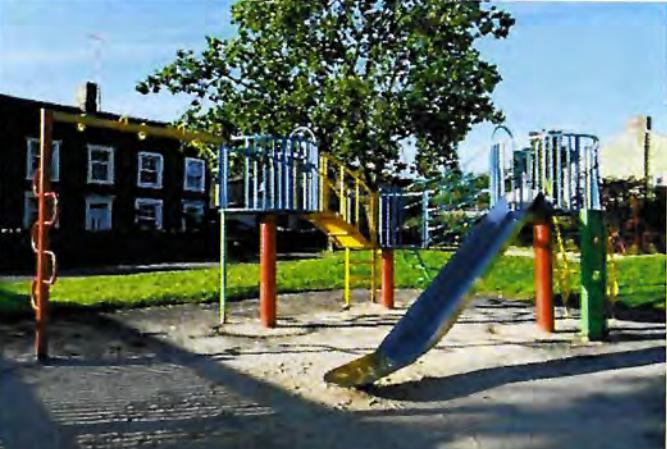
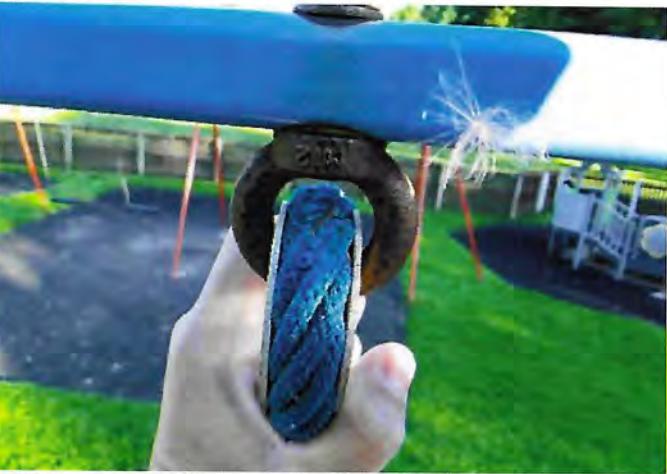
<b>Finding:</b> The ropes/nets are worn/damaged in places	<b>Action:</b> Monitor for any further deterioration and repair or replace as required

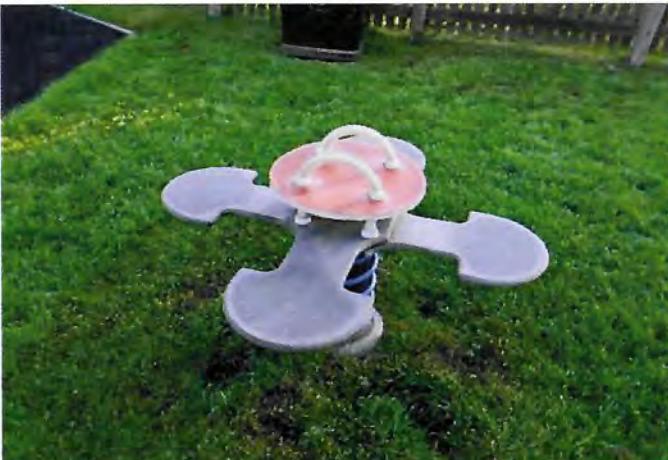
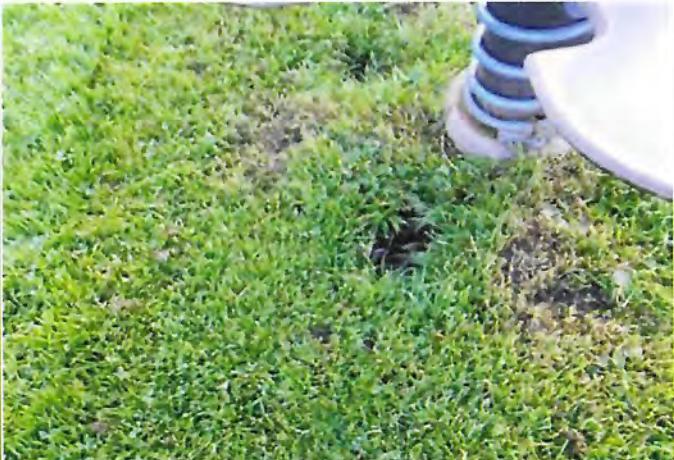
**Finding:** The grass has eroded within the impact area of the equipment and may not provide the necessary impact attenuating properties for the equipment fall height; the surface may also be slippery in wet weather

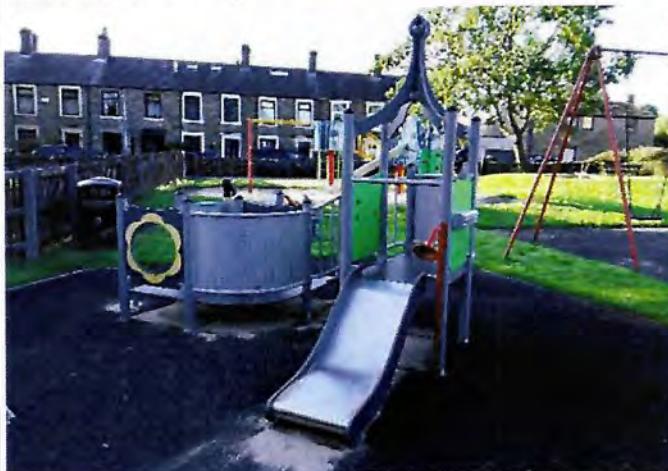
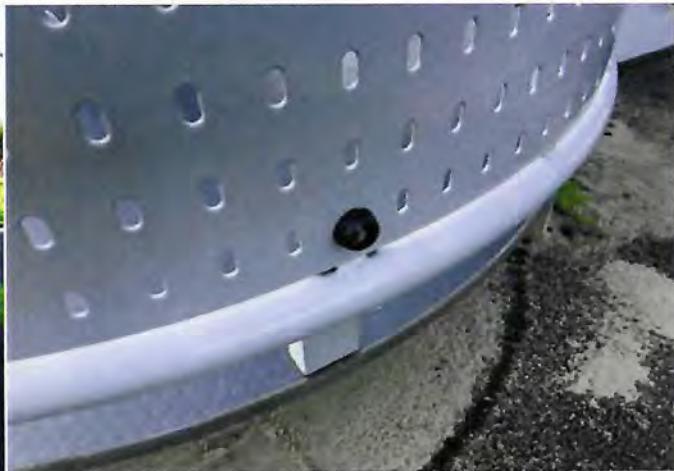
**Finding:** There is/are bolt cap covers missing or damaged on the item

**Action:** Replace missing or damaged bolt cap covers

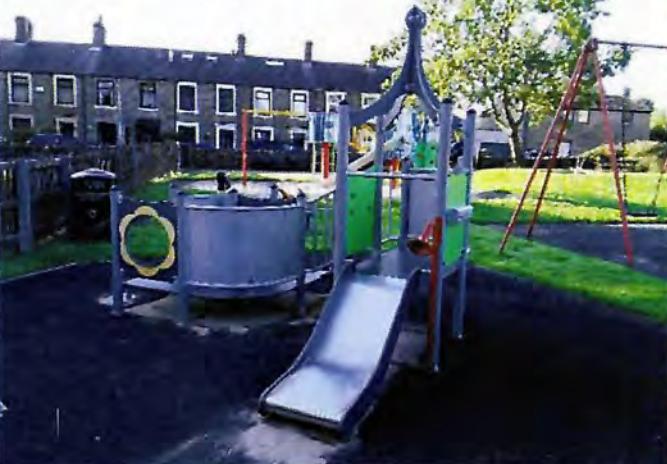
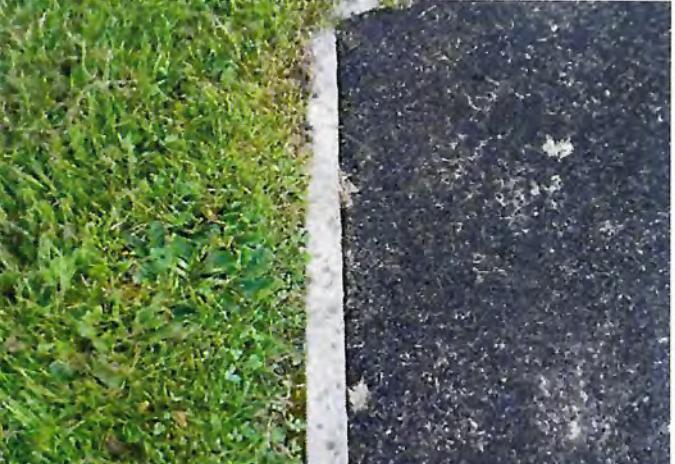
**Finding:** There are gaps opening between the surfacing and the edging surround or between the joints in the surfacing

**Action:** Monitor for any further deterioration and repair as required

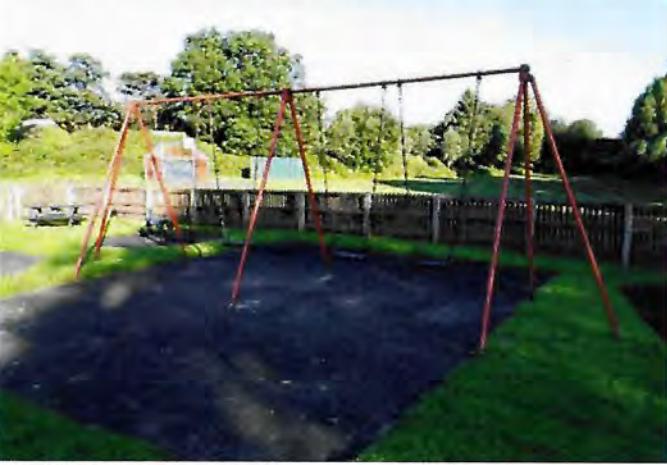
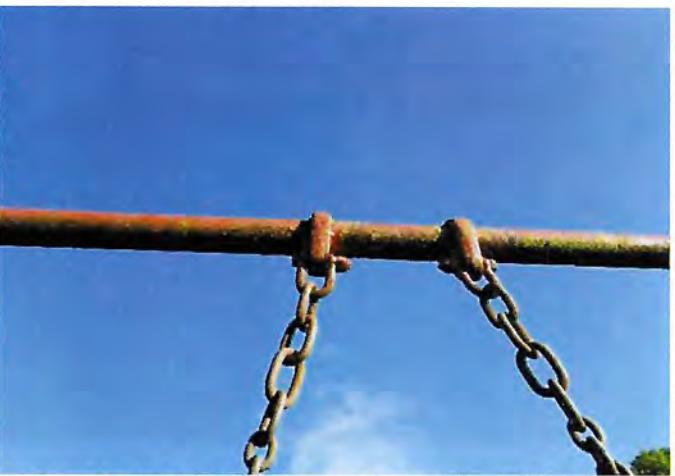
**Finding:** There is some wear to the shackles

**Action:** Monitor for any further deterioration and replace when 40% worn

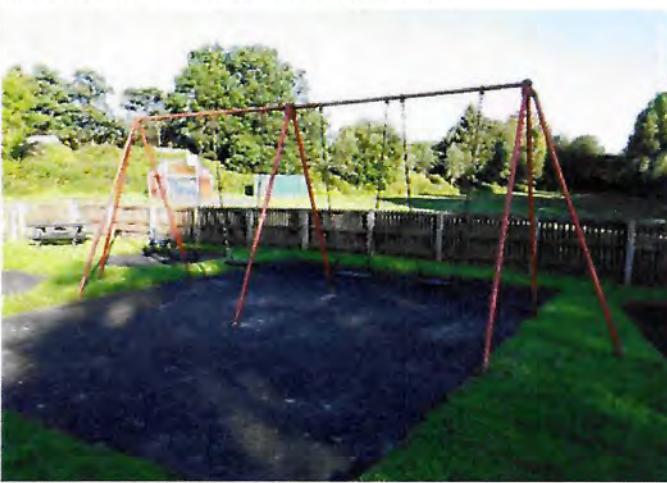
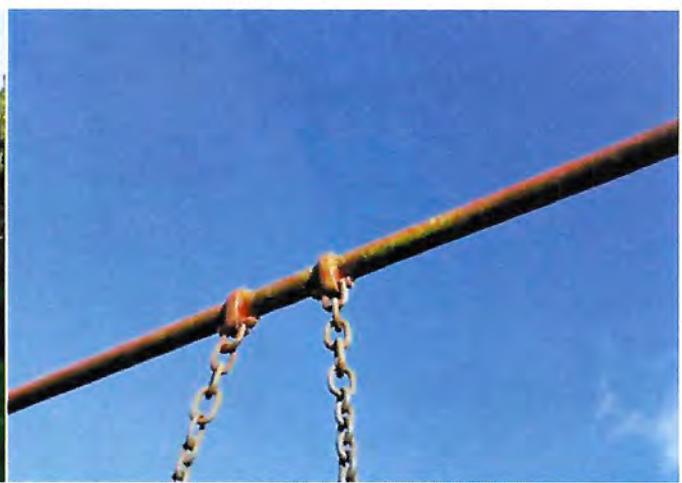
**Finding:** The bushes are worn or missing

**Action:** Replace worn or missing bushes

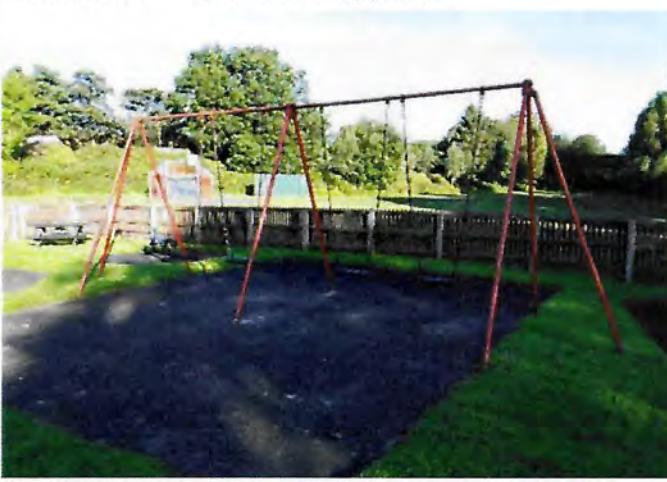
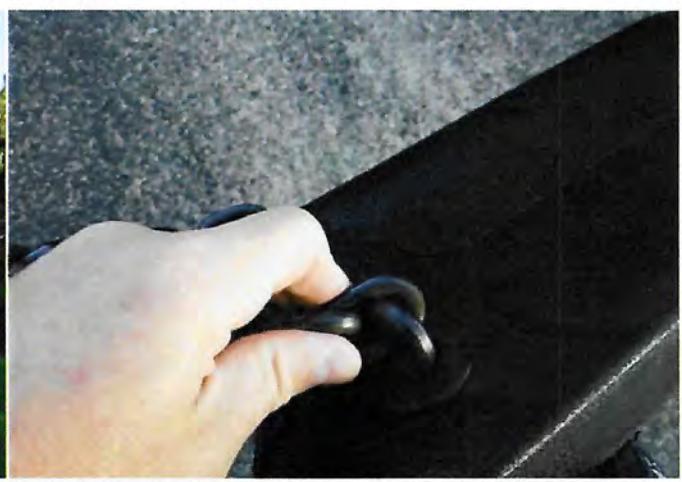
**Finding:** There is some notable evidence of chain wear

**Action:** Monitor for any further deterioration and replace when 40% worn

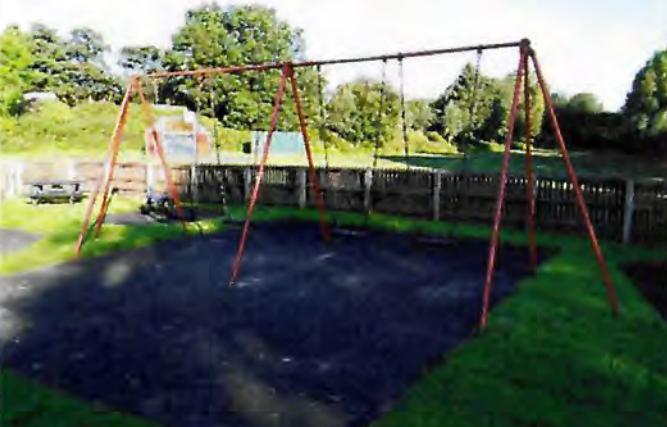
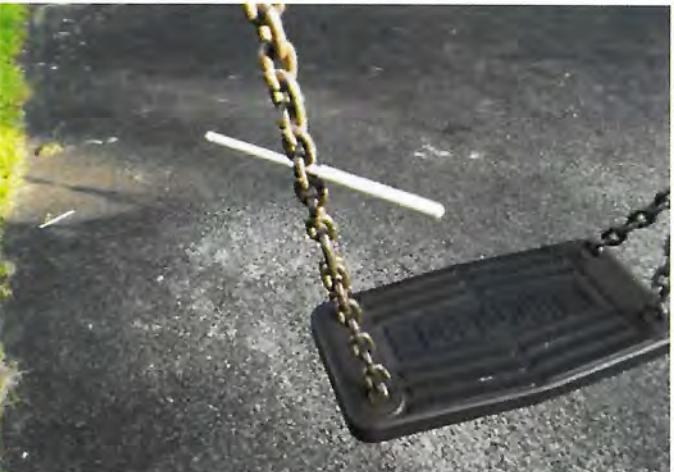
<b>Finding:</b> The chain openings are in excess of 8.6mm and do not meet the recommendations of BS EN 1176 Part 1	
<b>Action:</b> Monitor - No remedial work recommended

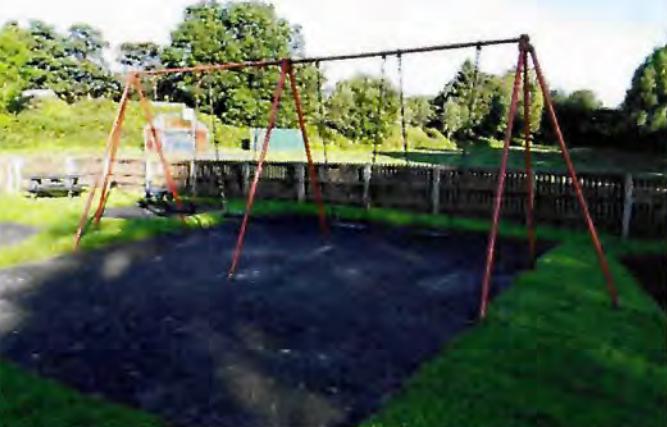
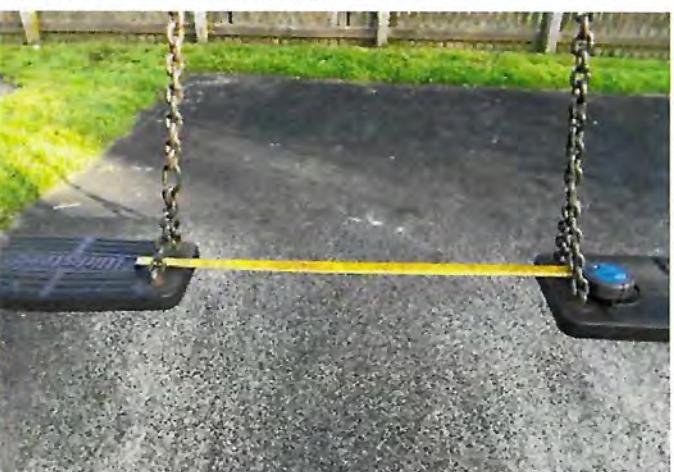
<b>Finding:</b> The seats are too close to each other as defined in BS EN 1176 Part 2; this is a low risk failure and no remedial action is required	
<b>Action:</b> Monitor - No remedial work recommended

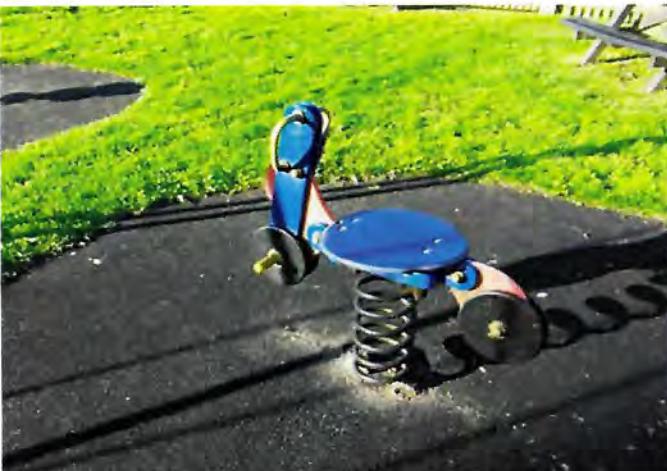
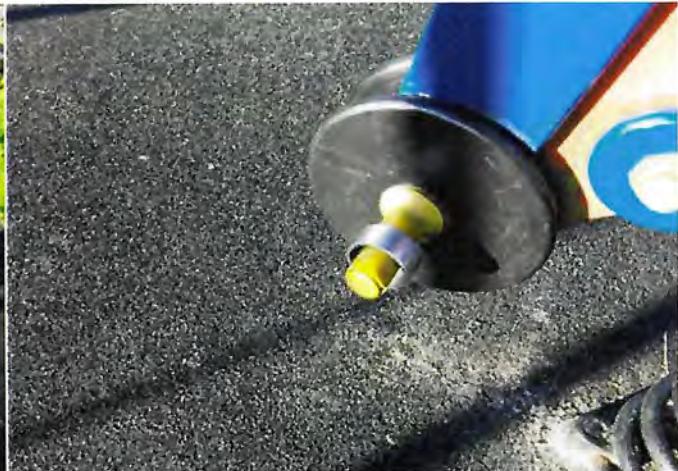
**Finding:** The end of handgrips and/or footrests have a cross section of less than 15cm<sup>2</sup> and fail to meet the requirements of BS EN 1176 Part 6

**Action:** Monitor - No remedial work recommended

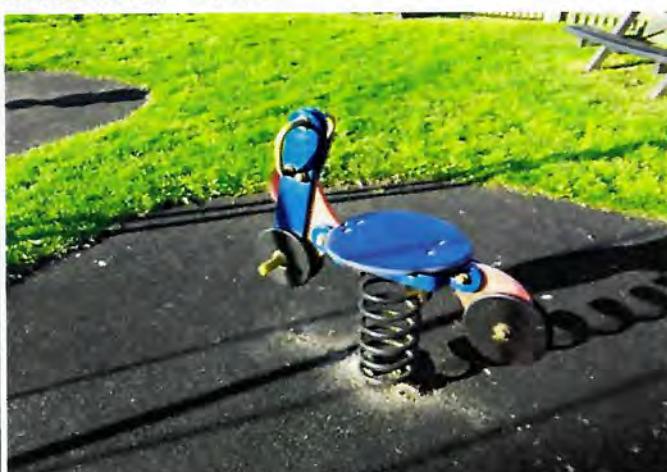
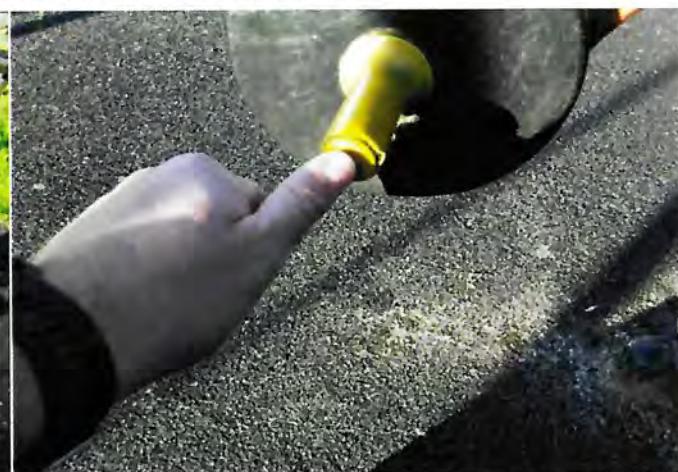
**Finding:** There is some damage to the footrests

**Action:** Monitor for any further deterioration and repair as required

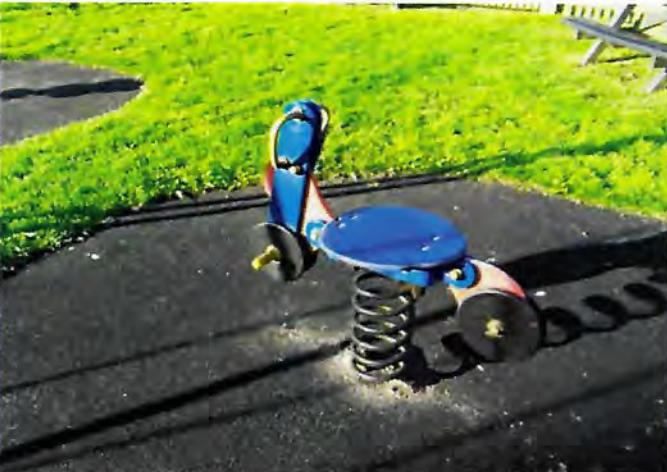
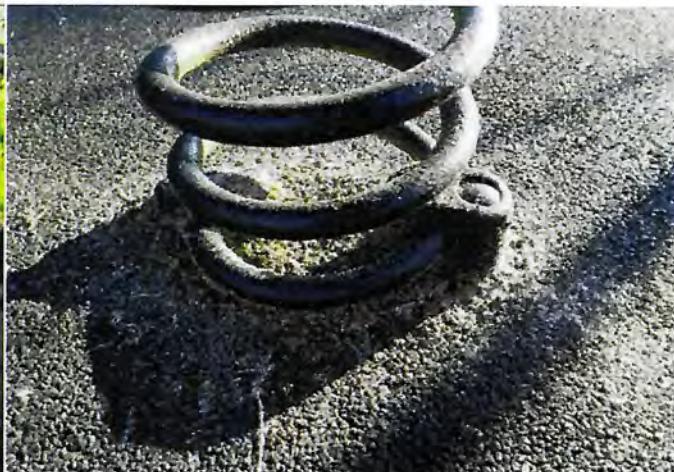
**Finding:** The U bolts clamping the spring are worn

**Action:** Monitor for any further deterioration and replace as required

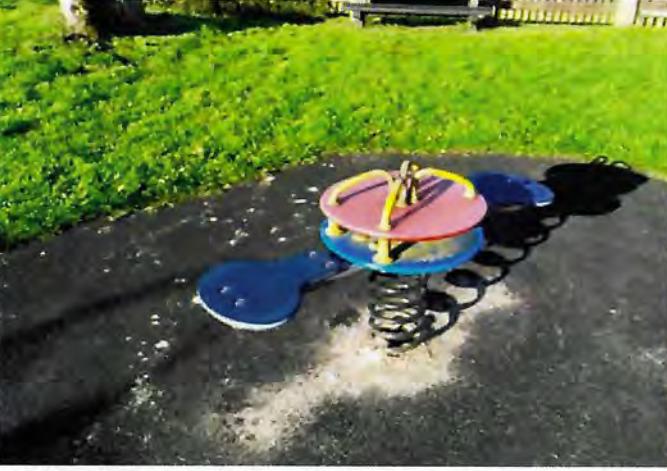
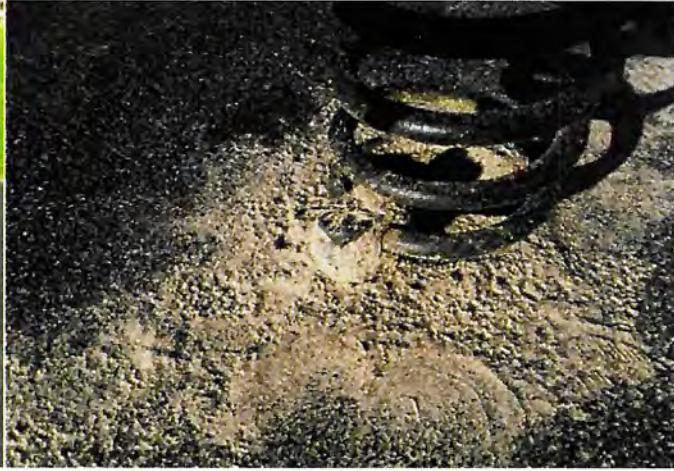
**Finding:** The U bolts clamping the spring are worn

**Action:** Monitor for any further deterioration and replace as required

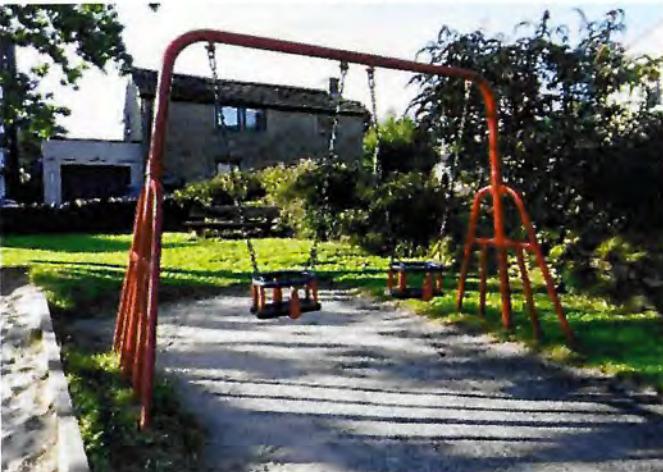
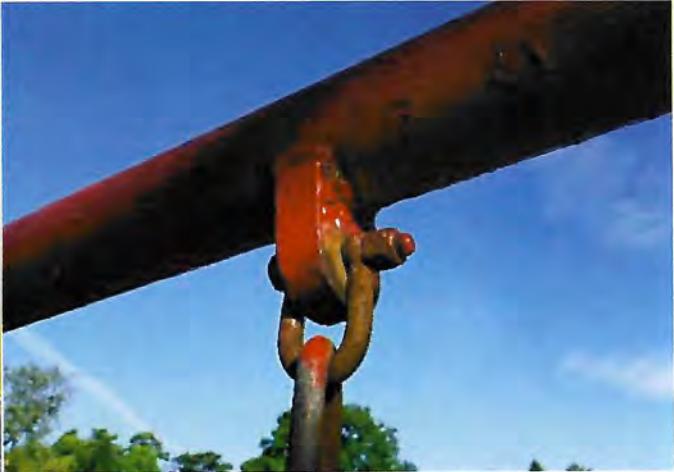
**Finding:** The bushes are showing signs of wear

**Action:** Monitor for any further deterioration and replace as required

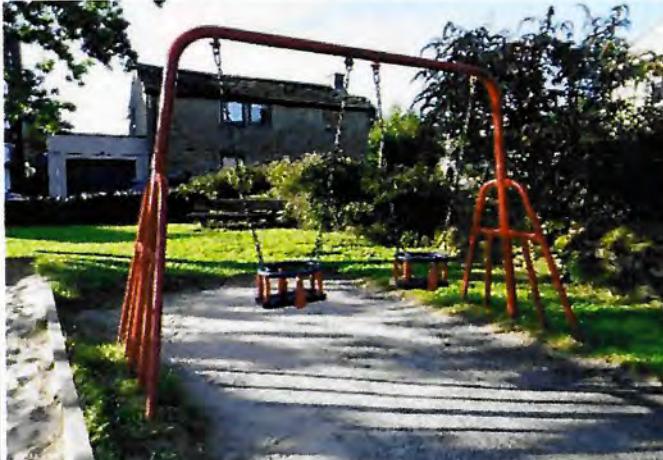
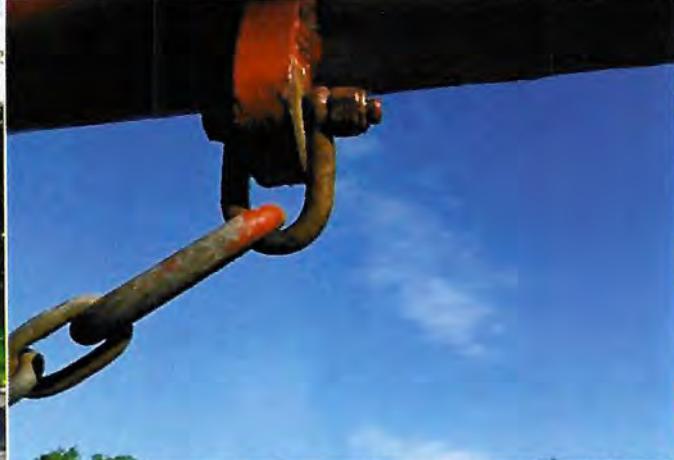
**Finding:** There is some wear to the shackles

**Action:** Monitor for any further deterioration and replace when 40% worn

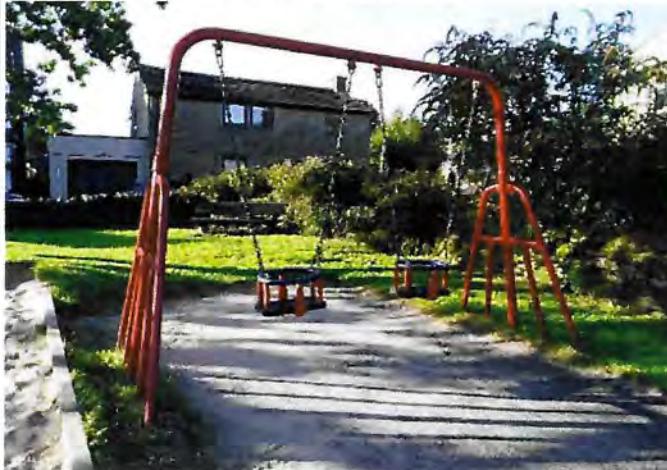
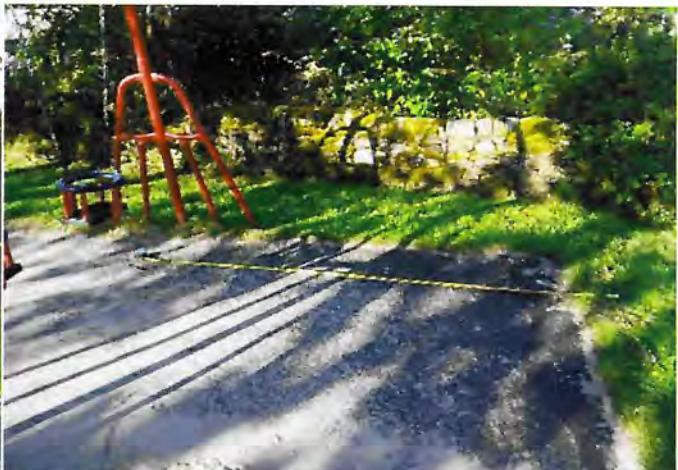
**Finding:** The surfacing dimensions are short and do not meet with the requirements of the current applicable standard

**Action:** Monitor - no remedial action recommended
