# the play inspection company

Annual Inspection

Pendle Borough Council

Salterforth

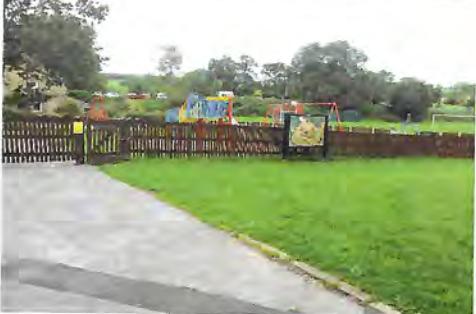
**i 8 - Low Risk**

**Item:** Site General  
**Manufacturer:** Owner/Operator  
**Surface Type:** N/A  
**Item Quantity:** 1  
**Equipment Compliance:** N/A  
**Surface Area Compliance:** N/A

**Finding 1**  
Sand has migrated onto the impact attenuating surface - Remove and maintain

**Finding 2**  
The adjacent grassed areas have encroached onto the impact attenuation surface - Cut back and maintain the grass

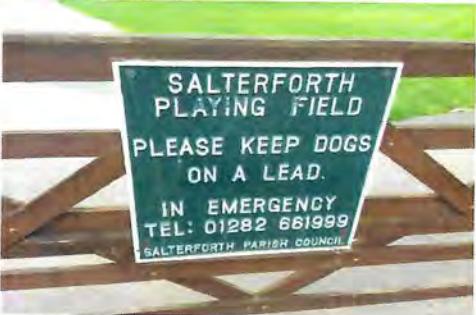
**Item:** Sign  
**Manufacturer:** Not Identified  
**Surface Type:** N/A  
**Item Quantity:** 1  
**Equipment Compliance:** N/A  
**Surface Area Compliance:** N/A

**Finding 1**  
BS EN 1176 Part 7 recommends that signage shall include the site name / address - Provide additional information

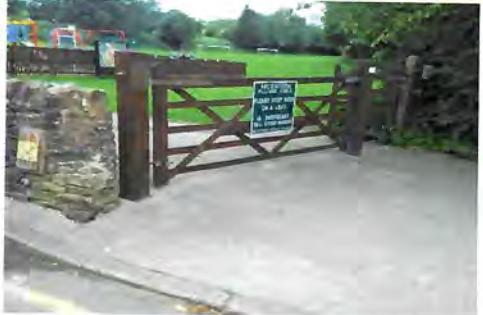
**Item:** Gate - Maintenance  
**Manufacturer:** Obra  
**Surface Type:** Bitmac  
**Item Quantity:** 1  
**Equipment Compliance:** N/A  
**Surface Area Compliance:** N/A

**Finding 1**  
There is no padlock on the maintenance gate - Provide a padlock to secure the gate

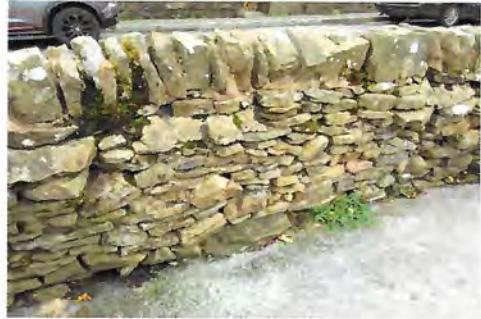
**Item:** Stone Wall  
**Manufacturer:** Owner/Operator  
**Surface Type:** N/A  
**Item Quantity:** 1  
**Equipment Compliance:** N/A  
**Surface Area Compliance:** N/A

**Finding 1**

There is algae or moss on the wall - Clean and treat appropriately

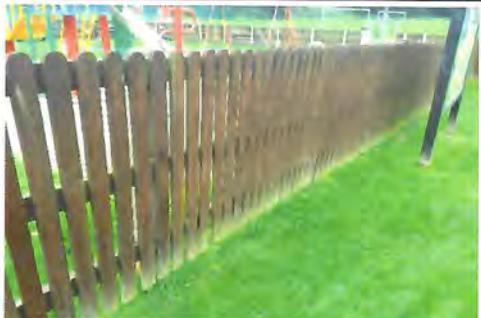
**Item:** Fencing - Timber  
**Manufacturer:** Owner/Operator  
**Surface Type:** N/A  
**Item Quantity:** 1  
**Equipment Compliance:** N/A  
**Surface Area Compliance:** N/A

**Finding 1**

There are projecting bolt thread(s) present - Remove excess thread length and deburr or provide cap

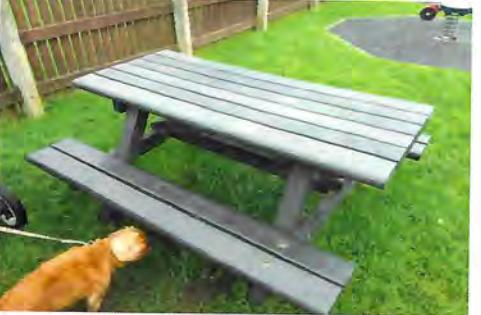
**Item:** Picnic Table  
**Manufacturer:** Owner/Operator  
**Surface Type:** Concrete  
**Item Quantity:** 1  
**Equipment Compliance:** N/A  
**Surface Area Compliance:** N/A

**Finding 1**  
There is minor damage to the bench - Monitor

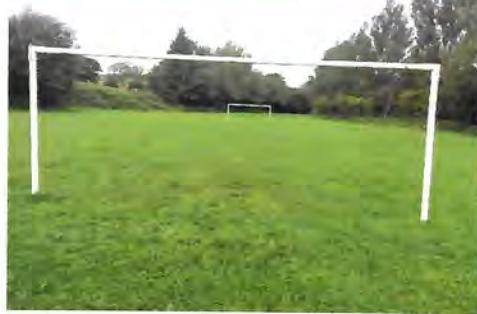
<b>Item:</b>	Football Goal

<b>Manufacturer:</b>	Harrod	
<b>Surface Type:</b>	Grass	
<b>Item Quantity:</b>	2	
<b>Equipment Compliance:</b>	N/A	
<b>Surface Area Compliance:</b>	N/A	
<b>Life Expectancy:</b>	3 - 5 Years	
<b>Total Findings:</b>	3

**Finding 1**  
The item is loose in its foundations - Reinstall item to secure

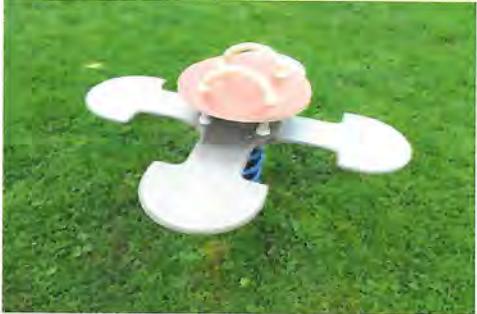
<b>Item:</b>	Spring Crazy Daisy

<b>Manufacturer:</b>	Not Identified	
<b>Surface Type:</b>	Grass	
<b>Item Quantity:</b>	1	
<b>Equipment Compliance:</b>	Yes	
<b>Surface Area Compliance:</b>	Yes	
<b>Life Expectancy:</b>	5 -10 Years	
<b>Total Findings:</b>	1

**Finding 1**  
The item is slightly loose in its foundations - Monitor for any further deterioration and repair as required

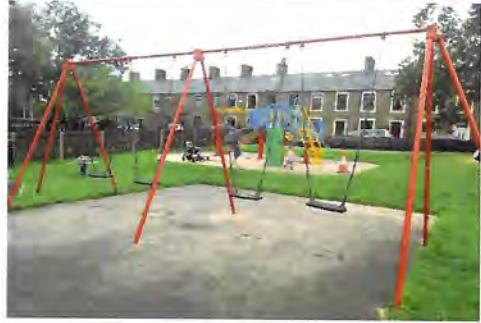
**Item:** 2 Bay 4 Seat (Flat)  
**Manufacturer:** Wicksteed Playgrounds  
**Surface Type:** Rubber Tiles  
**Item Quantity:** 1  
**Equipment Compliance:** No  
**Surface Area Compliance:** Yes  
**Life Expectancy:** 5 -10 Years  
**Total Findings:** 3

### Finding 1

The bushes are showing signs of wear - Monitor for any further deterioration and replace as required

There is some wear to the shackles. - Monitor for any further deterioration and replace when 40% worn

The seat is damaged and requires replacing - Replace damaged seat

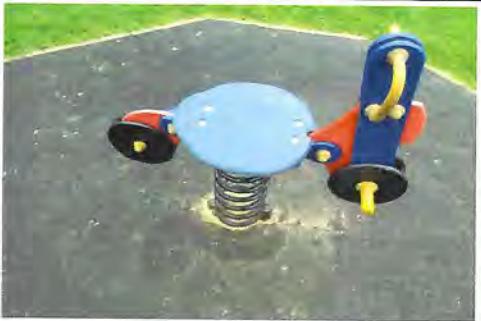
**Item:** Spring Bike  
**Manufacturer:** Ledon  
**Surface Type:** Wet Pour  
**Item Quantity:** 1  
**Equipment Compliance:** No  
**Surface Area Compliance:** Yes  
**Life Expectancy:** 5 -10 Years  
**Total Findings:** 2

### Finding 1

The end of handgrips and/or footrests have a cross section of less than 15cm<sup>2</sup> and fail to meet the requirements of BS EN 1176 Part 6 - Monitor - No remedial work recommended

The paintwork on the spring has been damaged or worn exposing the metal underneath which is rusting - Treat any rusting components and repaint

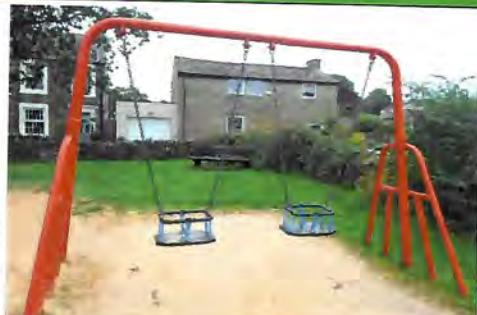
<b>Item:</b>	1 Bay 2 Seat (Cradle)
<b>Manufacturer:</b>	Wicksteed Playgrounds
<b>Surface Type:</b>	Wet Pour
<b>Item Quantity:</b>	1
<b>Equipment Compliance:</b>	Yes
<b>Surface Area Compliance:</b>	No
<b>Life Expectancy:</b>	5 -10 Years
<b>Total Findings:</b>	3

The bushes are showing signs of wear - Monitor for any further deterioration and replace as required

There is some wear to the shackles. - Monitor for any further deterioration and replace when 40% worn

**Finding 3**

The surfacing dimensions are short and do not meet with the requirements of the current applicable standard - Monitor - no remedial action recommended

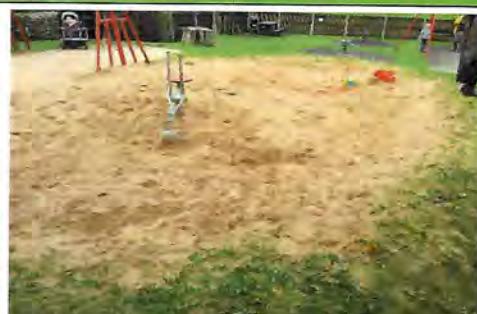
<b>Item:</b>	Sand Box
<b>Manufacturer:</b>	Not Identified
<b>Surface Type:</b>	Sand
<b>Item Quantity:</b>	1
<b>Equipment Compliance:</b>	Yes
<b>Surface Area Compliance:</b>	N/A

**Finding 1**  
Sand is migrating to adjacent surfaces - Provide appropriate sand retention

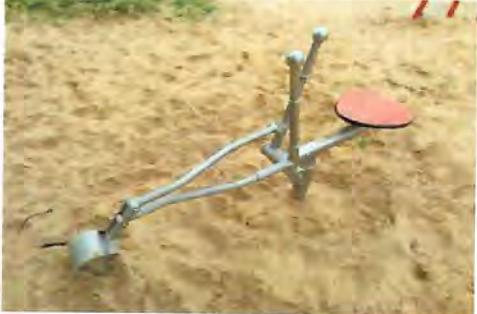
**Item:** Sand Play Unit  
**Manufacturer:** Hags  
**Surface Type:** Sand  
**Item Quantity:** 1  
**Equipment Compliance:** Yes  
**Surface Area Compliance:** N/A  
**Life Expectancy:** 5 -10 Years  
**Total Findings:** 1

**Finding 1**  
This item is satisfactory - no work required -

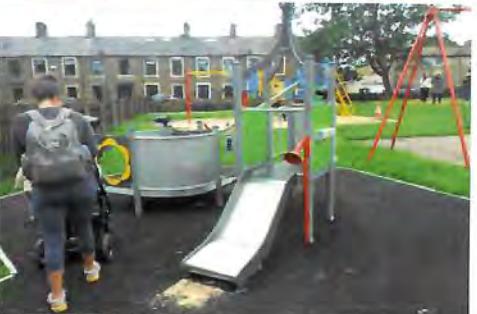
**Item:** Multi Play (Toddler)  
**Manufacturer:** Hags  
**Surface Type:** Wet Pour  
**Item Quantity:** 1  
**Equipment Compliance:** Yes  
**Surface Area Compliance:** Yes

**Finding 1**  
This item is satisfactory - no work required -

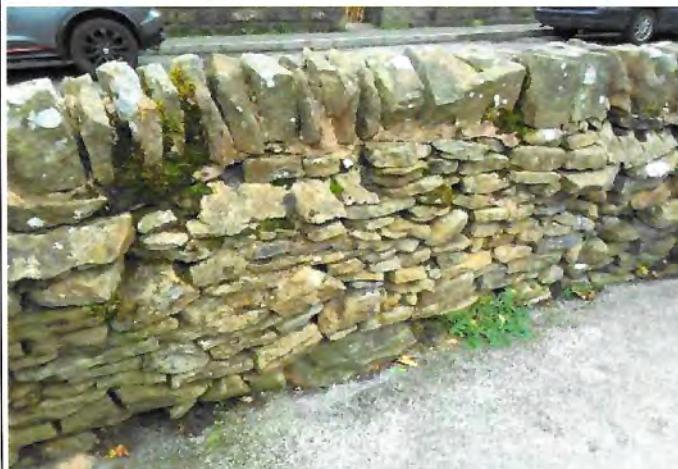
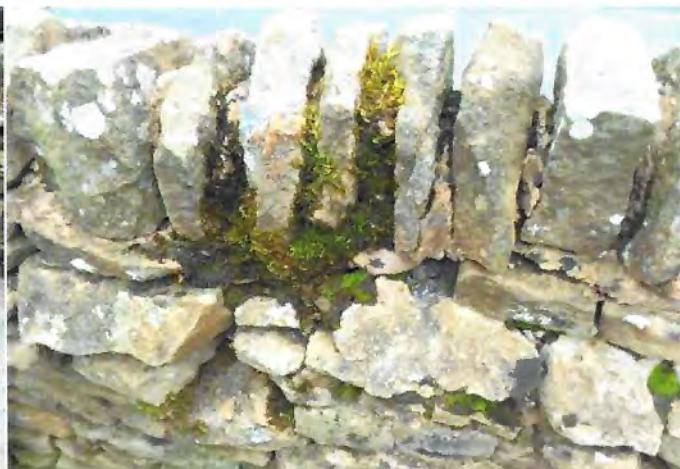
**Item:** Ancillary Items - Stone Wall  
**Manufacturer:** Owner/Operator

**Finding:** There is algae or moss on the wall

**Action:** Clean and treat appropriately

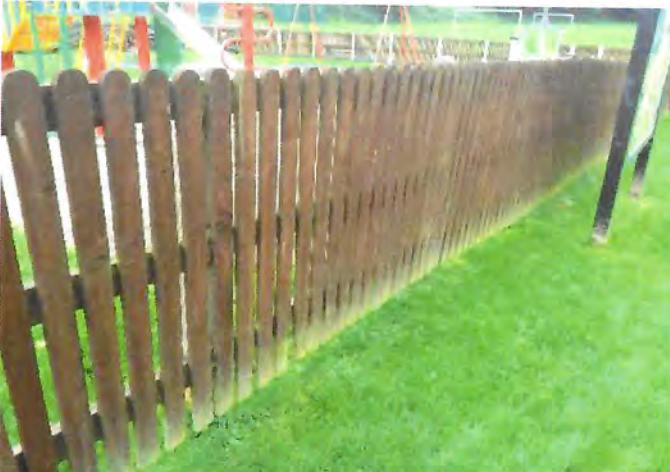
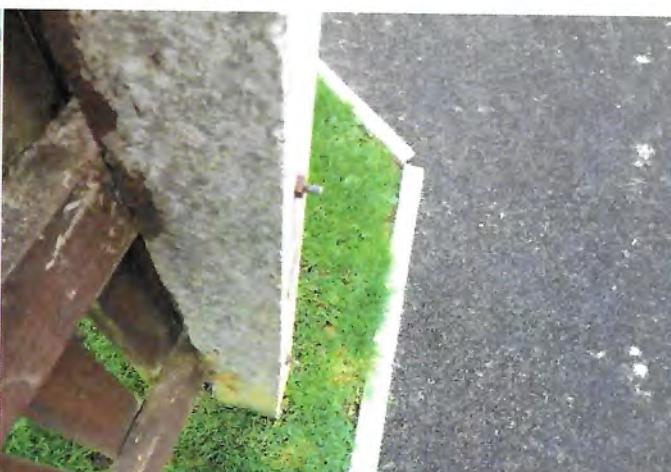
<b>Item:</b> Ancillary Items - Fencing - Timber <b>Manufacturer:</b> Owner/Operator	<b>Risk Level:</b> L - Low Risk <b>Surface:</b> N/A
--	--

**Finding:** There are projecting bolt thread(s) present

**Action:** Remove excess thread length and deburr or provide cap
