# the play inspection company

## Annual Inspection

Pendle Borough Council

Salterforth

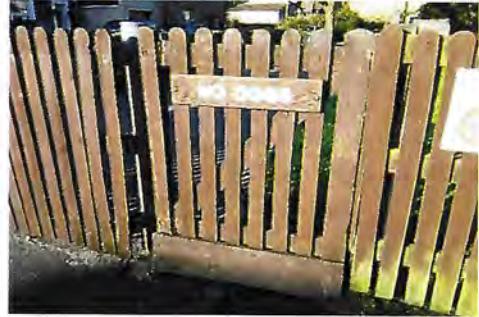
**Item:** Gate - Self Closing  
**Manufacturer:** Not Identified  
**Surface Type:** Bitmac  
**Item Quantity:** 2  
**Equipment Compliance:** N/A  
**Surface Area Compliance:** N/A

There is some damage to the item - Monitor for any further deterioration and repair as required

The area under the gate has eroded leaving uneven areas, or the concrete foundations exposed, resulting in trip hazards at the entrance/exit to the playground - Reinstate to level with surrounding surfaces

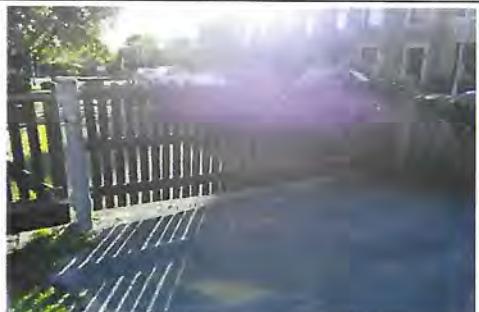
**Item:** Gate - Maintenance  
**Manufacturer:** Not Identified  
**Surface Type:** Bitmac  
**Item Quantity:** 1  
**Equipment Compliance:** N/A  
**Surface Area Compliance:** N/A

The maintenance gate was correctly padlocked at the time of inspection, however this means that the inspector was unable to fully assess the gate - Ensure that there are 12mm gaps throughout the full range of motion on gate/s and between leaves where relevant

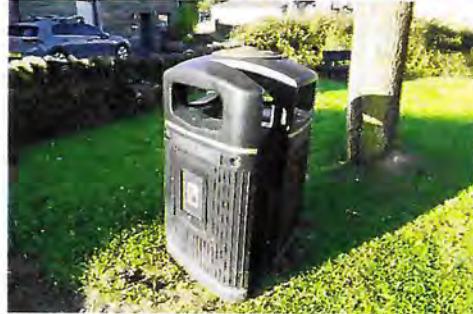
Item:	Litter Bin
Manufacturer:	Not Identified
Surface Type:	Grass
Item Quantity:	3
Equipment Compliance:	N/A
Surface Area Compliance:	N/A

The lid or door of the litter bin is not secured - Ensure the lid or door is kept locked

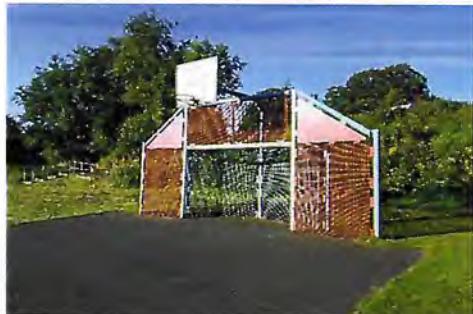
Item:	Goalmouth and Basketball Post
Manufacturer:	Parkdale Play & Leisure Ltd
Surface Type:	Tarmac
Item Quantity:	1
Equipment Compliance:	Yes
Surface Area Compliance:	N/A
Life Expectancy:	5 -10 Years
Total Findings:	1

The paintwork on this item has been damaged or worn exposing the metal underneath which is rusting / corroding - Treat affected areas and repaint

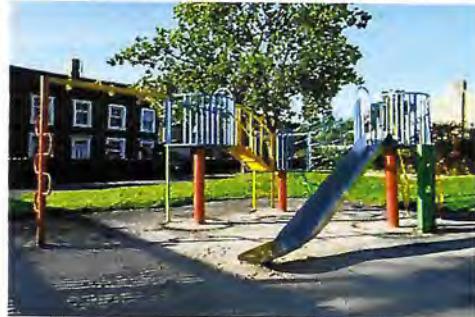
<b>Item:</b>	Multi Play (Junior)
<b>Manufacturer:</b>	Parkdale Play & Leisure Ltd
<b>Surface Type:</b>	Wet Pour
<b>Item Quantity:</b>	1
<b>Equipment Compliance:</b>	No
<b>Surface Area Compliance:</b>	Yes
<b>Life Expectancy:</b>	5 -10 Years
<b>Total Findings:</b>	5

There are a number of dents in the slide surface - Monitor for any further deterioration and repair as required

There is/are bolt cap covers missing or damaged on the item - Replace missing or damaged bolt cap covers

The paintwork on this item has been damaged or worn exposing the metal underneath which is rusting / corroding - Treat affected areas and repaint

The connecting links are in excess of 8.6mm and less than 12mm and fail the requirements of BS EN 1176 Part 1; clause 4.2.13, Chains - Monitor use and replace with compliant links at the next maintenance cycle

The ropes/nets are worn/damaged in places - Monitor for any further deterioration and repair or replace as required

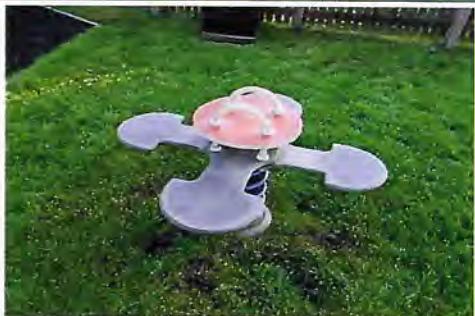
<b>Item:</b>	Spring Crazy Daisy
<b>Manufacturer:</b>	Not Identified
<b>Surface Type:</b>	Grass
<b>Item Quantity:</b>	1
<b>Equipment Compliance:</b>	Yes
<b>Surface Area Compliance:</b>	Yes
<b>Life Expectancy:</b>	5 -10 Years
<b>Total Findings:</b>	1

The grass has eroded within the impact area of the equipment and may not provide the necessary impact attenuating properties for the equipment fall height; the surface may also be slippery in wet weather - Reinstate the grass or provide an all weather surface

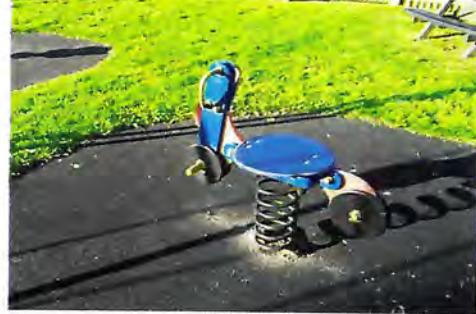
<b>Item:</b>	Spring See-Saw
<b>Manufacturer:</b>	Fahr Industries
<b>Surface Type:</b>	Wet Pour
<b>Item Quantity:</b>	1
<b>Equipment Compliance:</b>	Yes
<b>Surface Area Compliance:</b>	Yes
<b>Life Expectancy:</b>	5 -10 Years
<b>Total Findings:</b>	1

**Finding 1**  
The U bolts clamping the spring are worn - Monitor for any further deterioration and replace as required

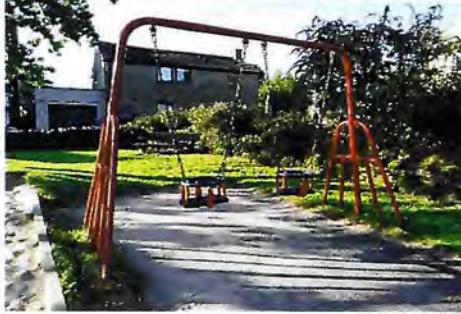
<b>Item:</b>	1 Bay 2 Seat (Cradle)

**Finding 1**  
The bushes are showing signs of wear - Monitor for any further deterioration and replace as required

**Finding 2**  
There is some wear to the shackles - Monitor for any further deterioration and replace when 40% worn

**Finding 3**  
The surfacing dimensions are short and do not meet with the requirements of the current applicable standard - Monitor - no remedial action recommended
